## Facility Condition Report

Sample Deliverable 2

Interstate Roof Systems  
Consultants, Inc.  
16680 W. Cleveland Ave. Ste A,  
New Berlin, Wisconsin, 53151

**Date:** October 11, 2022

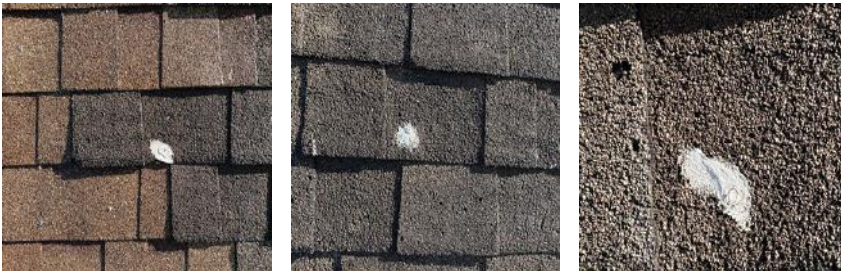
Defect Area	Defect Type	Status	Severity	Quantity	Unit
Roof Type	Repairs Overview	Outstanding	Moderate	N/A	N/A

Caulk repairs were made to shingles throughout roof system.

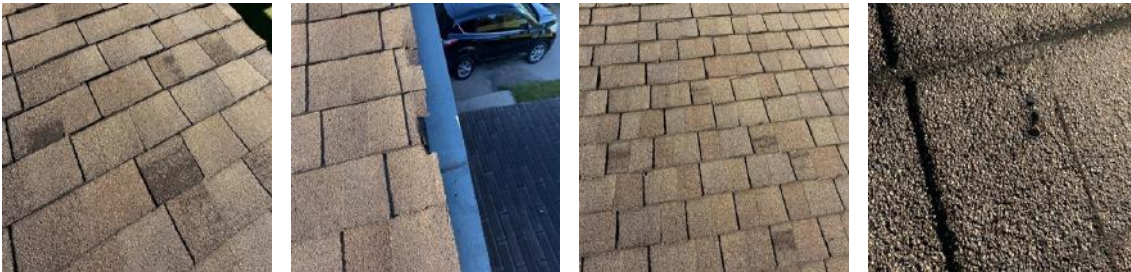
Roof Type	Shingle Damage	Outstanding	Moderate	N/A	N/A
-----------	----------------	-------------	----------	-----	-----

Shingle damage was noted throughout the roof field.  
Damages include major granular loss and bent or ripped shingles.

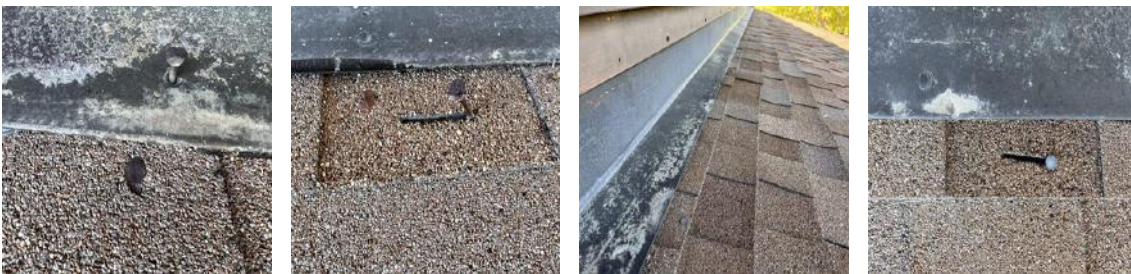
Defect Area	Defect Type	Status	Severity	Quantity	Unit
Roof Type	Counter Flashing	Outstanding	Moderate	222	L/F

The counterflashing below the windows is starting to lift and expose nails.

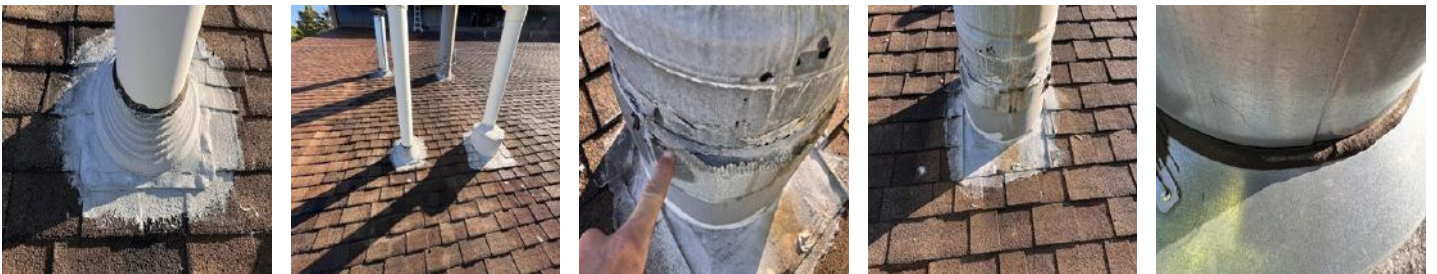
Defect Area	Defect Type	Status	Severity	Quantity	Unit
Roof Type	Flashing	Outstanding	Major	4	Ea.

Rain collars are missing on the flue stacks and the sealant is deteriorating.

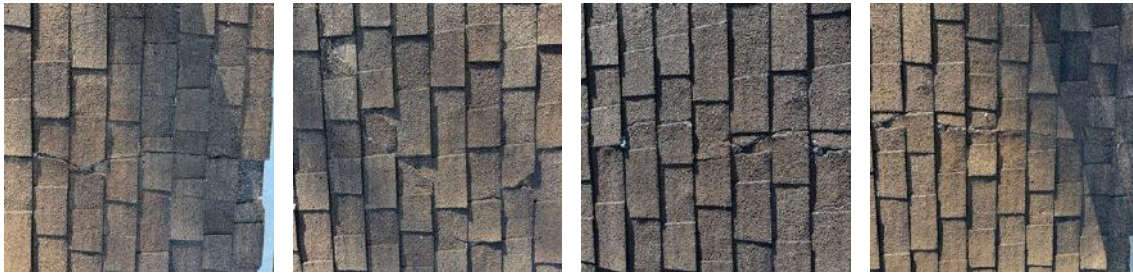
Defect Area	Defect Type	Status	Severity	Quantity	Unit
Roof Type	Cracking	Outstanding	Major	30	sq. ft.

Shingles are cracking along all bottom roof edges.

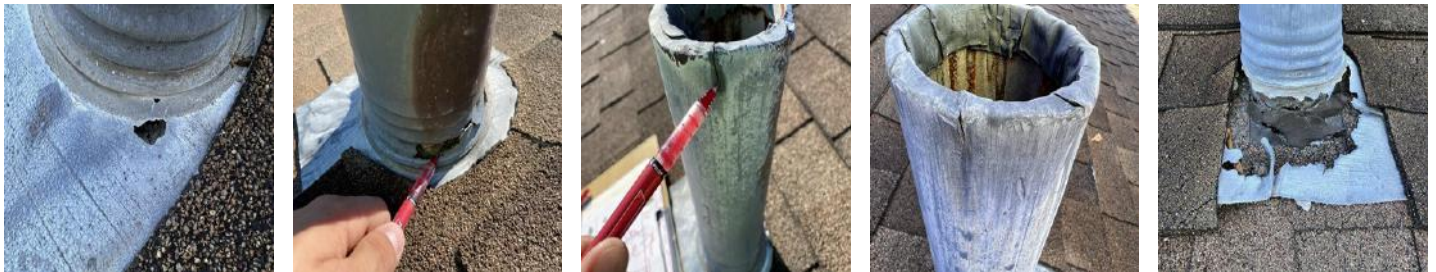
Defect Area	Defect Type	Status	Severity	Quantity	Unit
Roof Type	Deteriorated Flashing	Outstanding	Major	7	Ea.

Multiple soil stacks with lead pipe flashing were deteriorated and open.

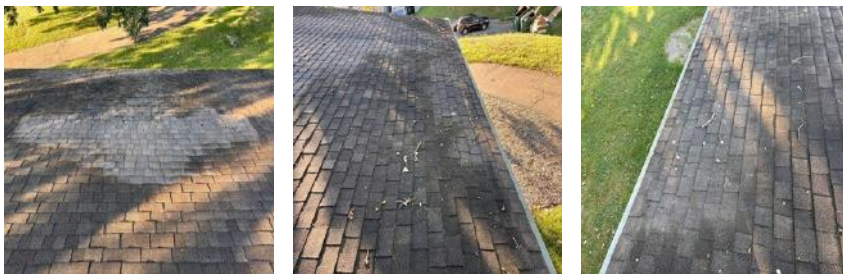
Defect Area	Defect Type	Status	Severity	Quantity	Unit
Roof Type	Wet Insulation	Outstanding	Major	15	sq. ft.

Areas of the roof were deflecting/sinking due to insulation being wet.

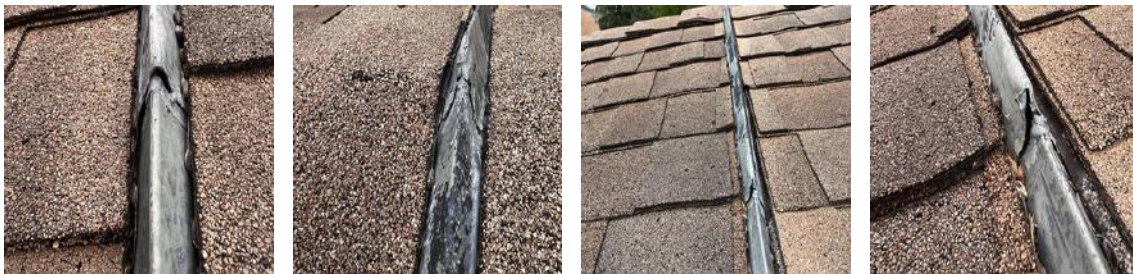
Defect Area	Defect Type	Status	Severity	Quantity	Unit
Roof Type	Expansion Joint	Outstanding	Moderate	N/A	N/A

Expansion joint seams are open.

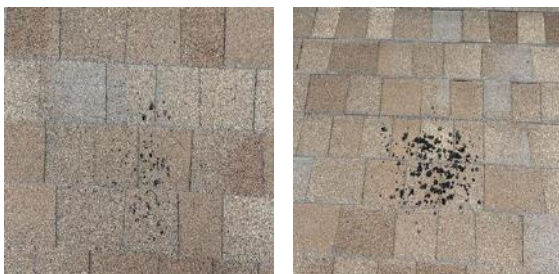
Defect Area	Defect Type	Status	Severity	Quantity	Unit
Roof Type	Spill Damage	Outstanding	Moderate	2	Ea.

Asphalt drips from the upper roof were noted on the bottom room.

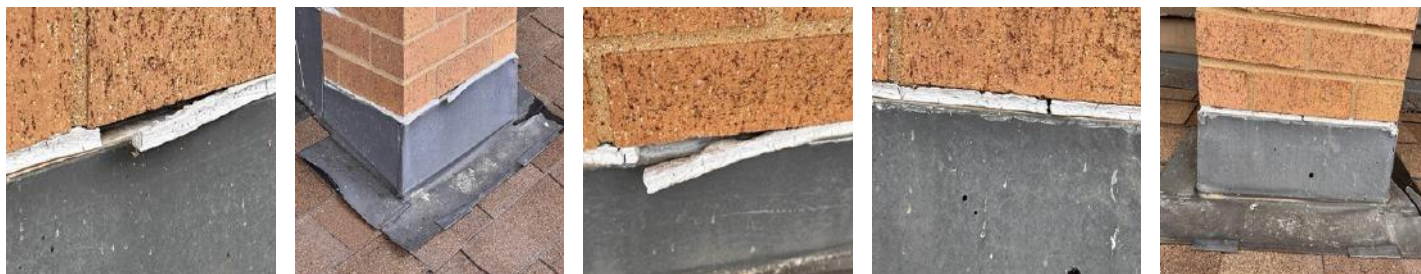
Defect Area	Defect Type	Status	Severity	Quantity	Unit
Roof Type	Counterflashing Loose	Outstanding	Major	N/A	N/A

Counterflashing along the windows are starting to loosen and open up.

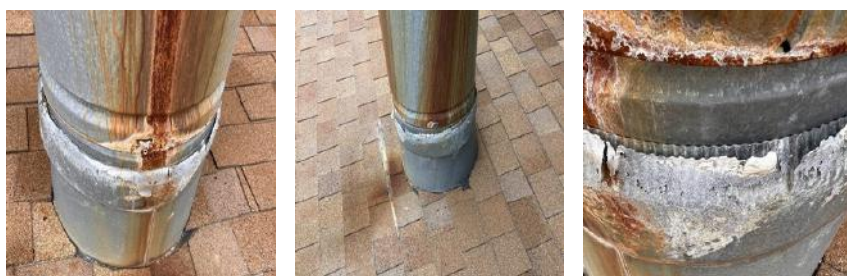
Defect Area	Defect Type	Status	Severity	Quantity	Unit
Roof Type	Flashing Open	Outstanding	Moderate	N/A	N/A

Flue stack and abandoned vent metal flashings are open.

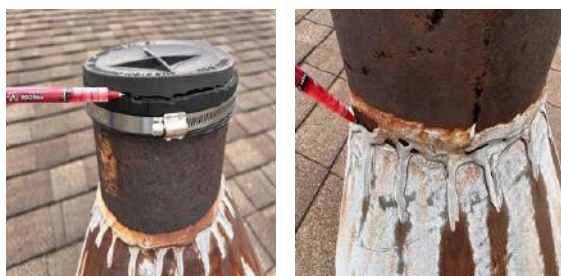
Defect Area	Defect Type	Status	Severity	Quantity	Unit
Roof Type	Flashing	Outstanding	Major	N/A	N/A

Lead soil stack flashings are deteriorated and open.

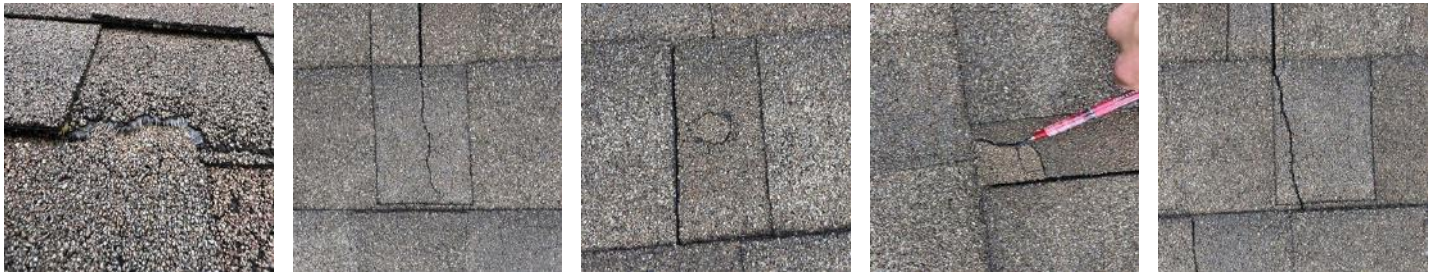
Defect Area	Defect Type	Status	Severity	Quantity	Unit
Roof Type	Shingle Damage	Outstanding	Moderate	N/A	N/A

Cracked and damaged shingles were observed throughout the roof system.

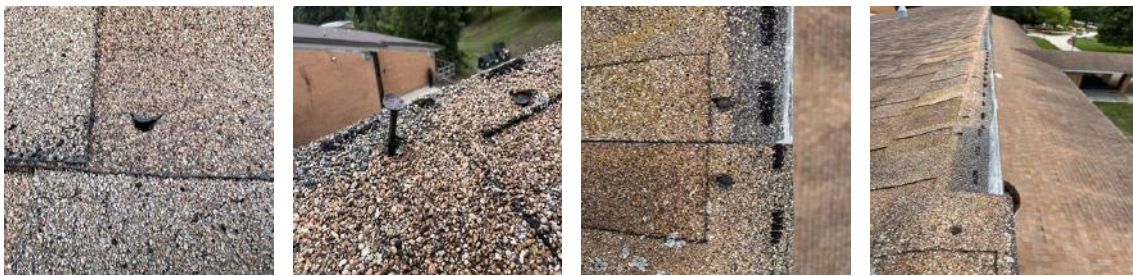
Defect Area	Defect Type	Status	Severity	Quantity	Unit
Roof Type	Exposed Fasteners	Outstanding	Major	N/A	N/A

It was observed that nails were exposed throughout the roof system.

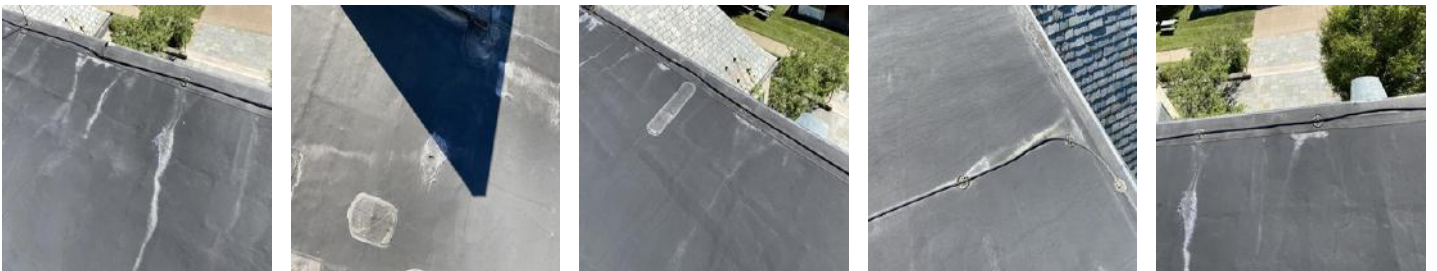
Defect Area	Defect Type	Status	Severity	Quantity	Unit
Roof Type	Exposed Scrim Reinforcement	Outstanding	Major	N/A	N/A

Exposed reinforcement scrim was noted throughout the roof membrane.

Roof replacement for roof section C10 - EPDM is highly recommended.

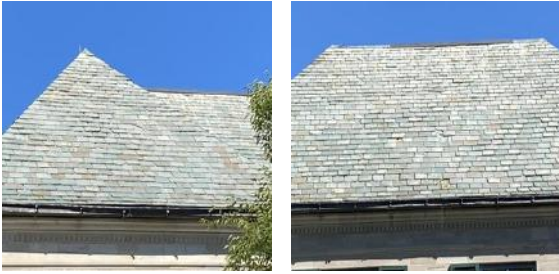
It was noted that a total of 24 slate shingles were missing.

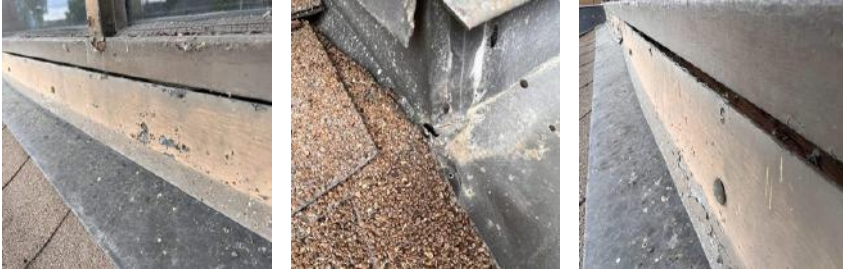
Defect Area	Defect Type	Status	Severity	Quantity	Unit
Roof Type	Counterflashing Loose	Outstanding	Major	10	L/F
<b>Notes:</b> The counter flashing under the windows is loose and is open.

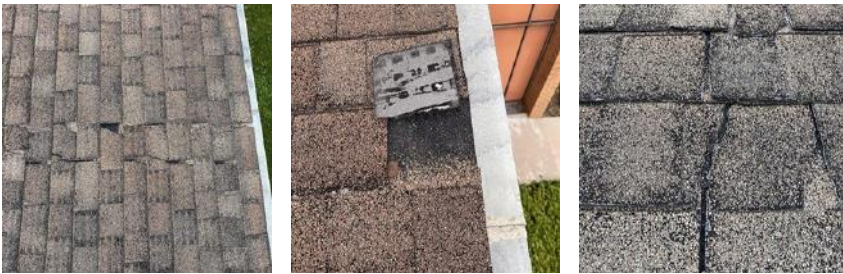
Defect Area	Defect Type	Status	Severity	Quantity	Unit
Roof Type	Shingle Damage	Outstanding	Major	N/A	N/A

Shingle damage was noted throughout the roof system.

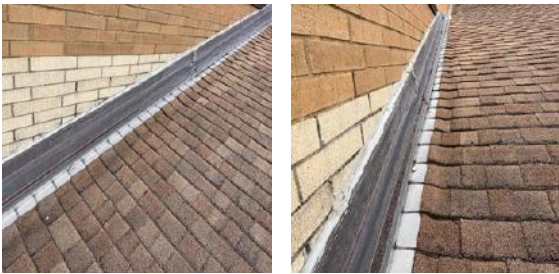
Improper stepflashing detail was installed.

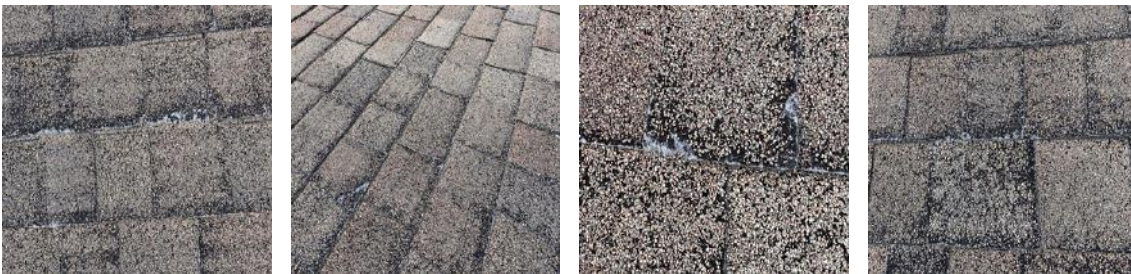
Defect Area	Defect Type	Status	Severity	Quantity	Unit
Roof Type	Granular Erosion	Outstanding	Major	N/A	N/A

Major granular erosion was noted throughout the roof system.

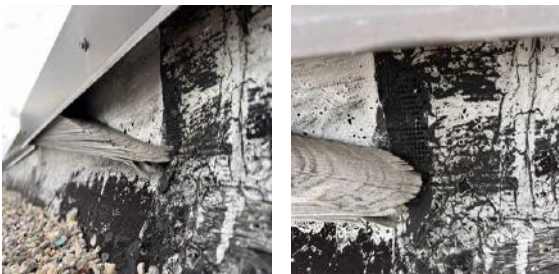
Wood nailer is damaged and hanging below the metal coping.

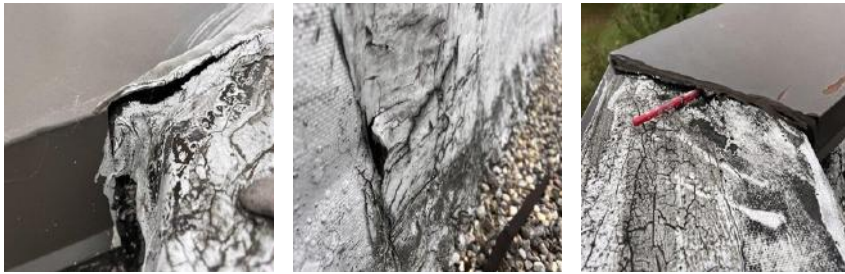
Defect Area	Defect Type	Status	Severity	Quantity	Unit
Roof Type	Open Perimeter Coping	Outstanding	Major	5	Ea.

Metal coping joints are open along the parapet wall.

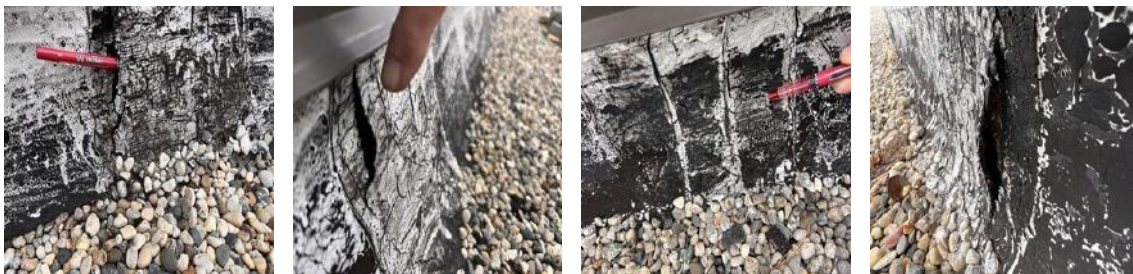
Base flashing was open throughout the roof system.

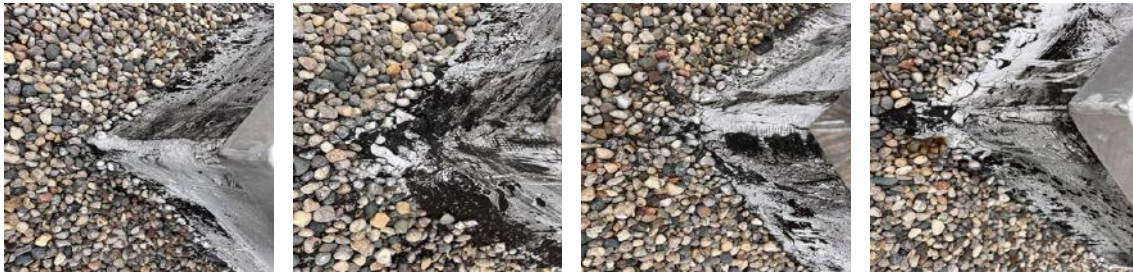
Defect Area	Defect Type	Status	Severity	Quantity	Unit
Roof Type	Open corner flashing	Outstanding	Major	4	Ea.

Corner flashings were open on the raised roof area and vents.

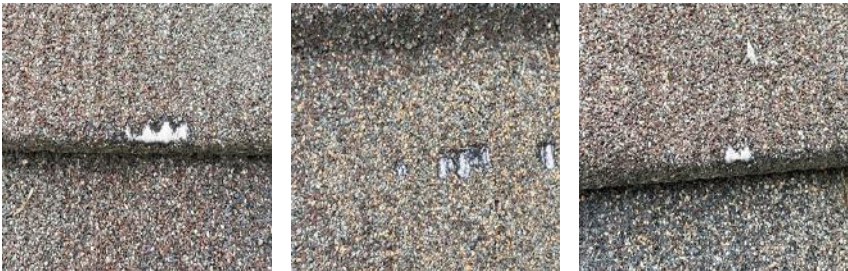
Defect Area	Defect Type	Status	Severity	Quantity	Unit
Roof Type	Shingle Damage	Outstanding	Minor	10	sq. ft.
<b>Notes:</b> Shingle damage was noted along the roof edge.

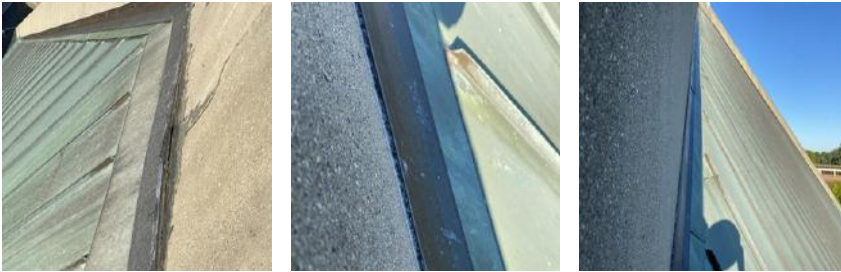
The caulk is deteriorating/open along the top of the metal standing panels.

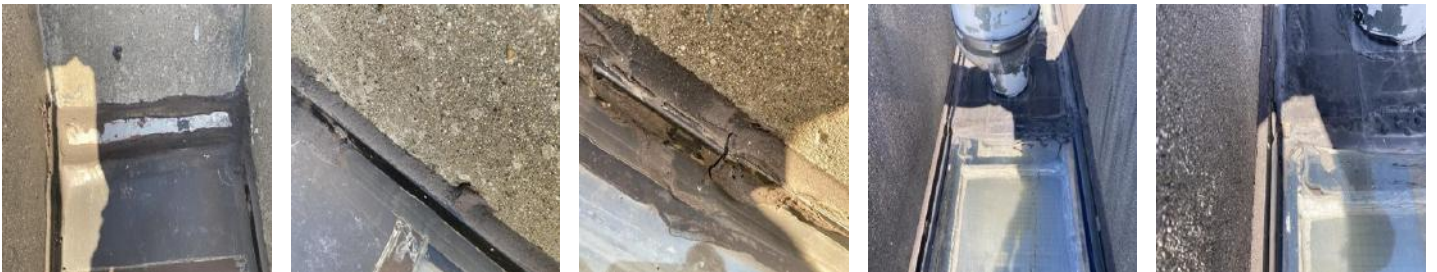
Defect Area	Defect Type	Status	Severity	Quantity	Unit
Roof Type	Caulking Deterioration	Outstanding	Moderate	10	L/F

The caulk along the glass panes is starting to deteriorate.

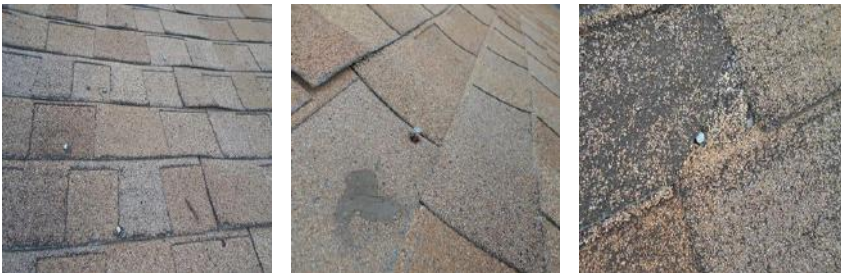
Exposed fasteners were noted throughout the roof system.

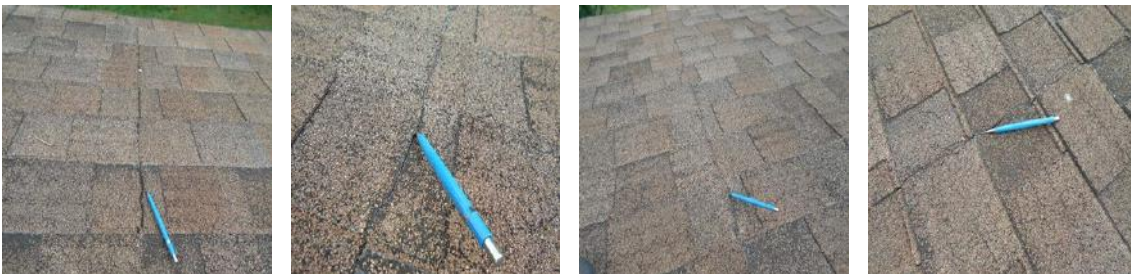
Defect Area	Defect Type	Status	Severity	Quantity	Unit
Roof Type	Crack	Outstanding	Major	30	Ea.

Cracks were noted in the shingles throughout the roof system.

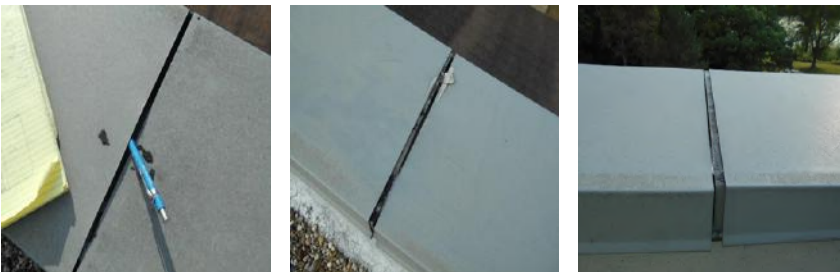
It was noted that the metal coping joints were open along the roof edges.

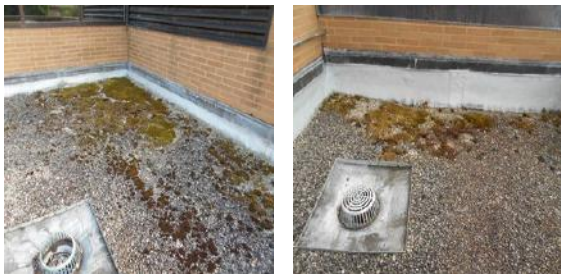
Defect Area	Defect Type	Status	Severity	Quantity	Unit
Roof Type	Vegetation/moss/growth	Outstanding	Moderate	20	sq. ft.

Vegetation growth was noted on two of the built-up roofs.
