Facility Condition Report

Interstate Roof Systems Consultants, Inc. 16680 W. Cleveland Ave. Ste A, New Berlin, Wisconsin, 53151

Date: October 21, 2021

Facility Condition Report Cedarburg High School

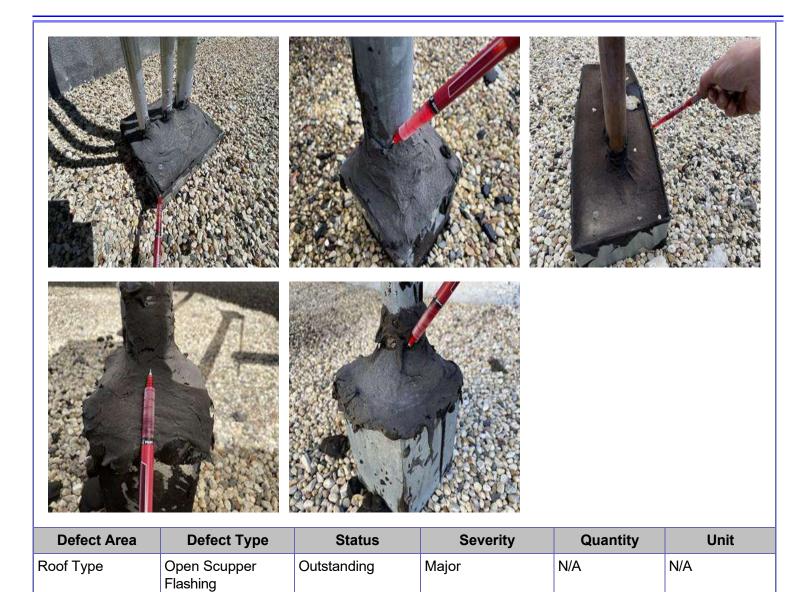
Roof Defects Section: 1, 2, 4, 6, 7							
Defect Area	Defect Type	Status	Severity	Quantity	Unit		
Roof Type	Open Pitch Pan	Outstanding	Major	N/A	N/A		
Notes: Open pitch	Notes: Open pitch pocket flashings throughout the roof system.

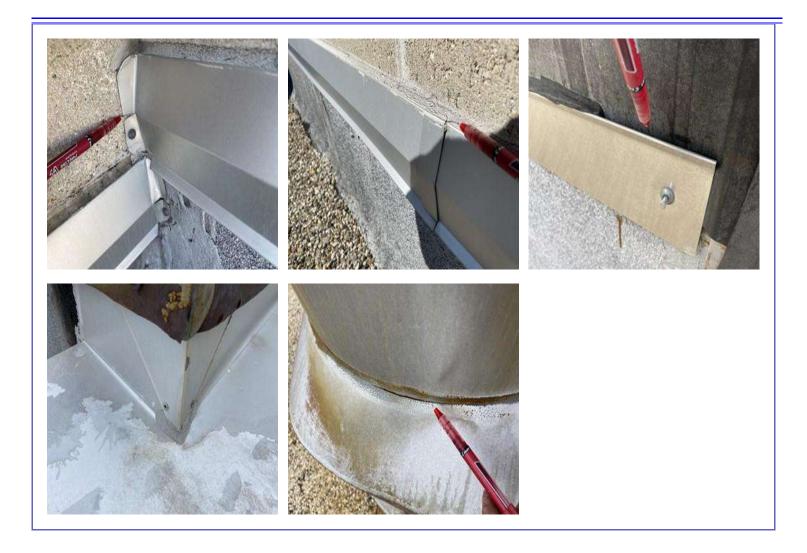
Notes: Open caulk seals at metal counter flashings, metal curb flashings, tall cone rain collar penetrations, throughout the roof systems.

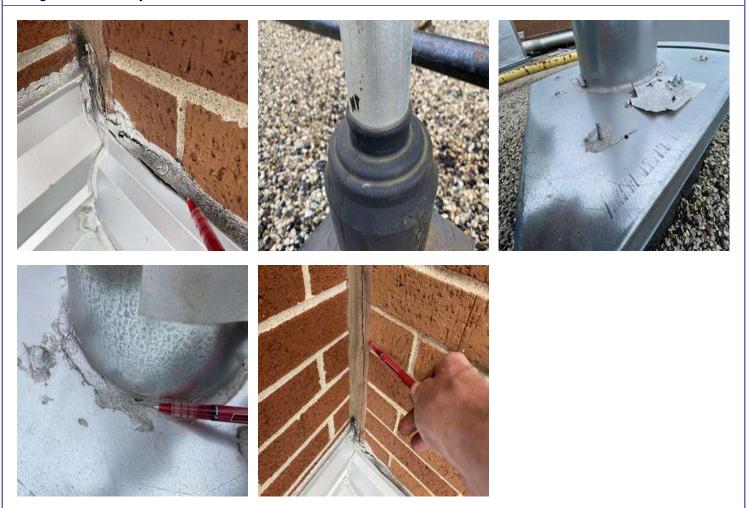
Notes: Open caulk joint at metal counter flashings, tall cone flashings, masonry corner joint, boot flashings throughout the roof systems.

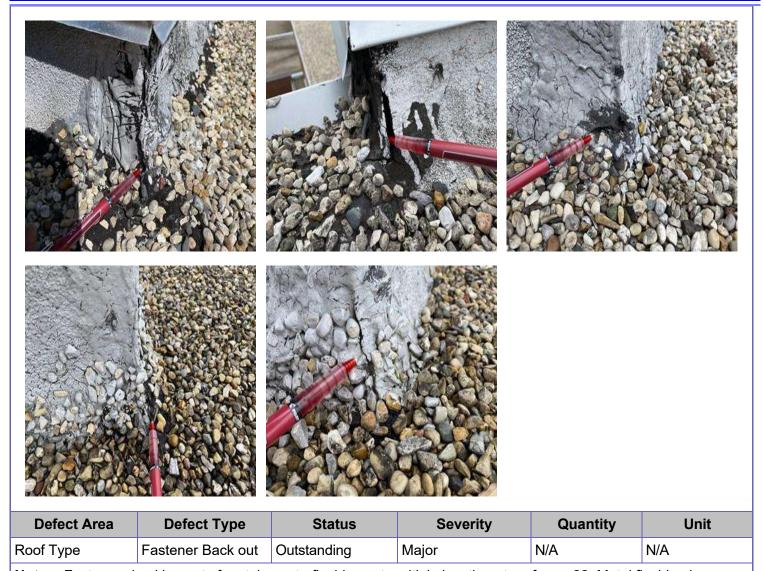
Notes: Split open flashings at curb corners and perimeter flashings throughout the roof systems.

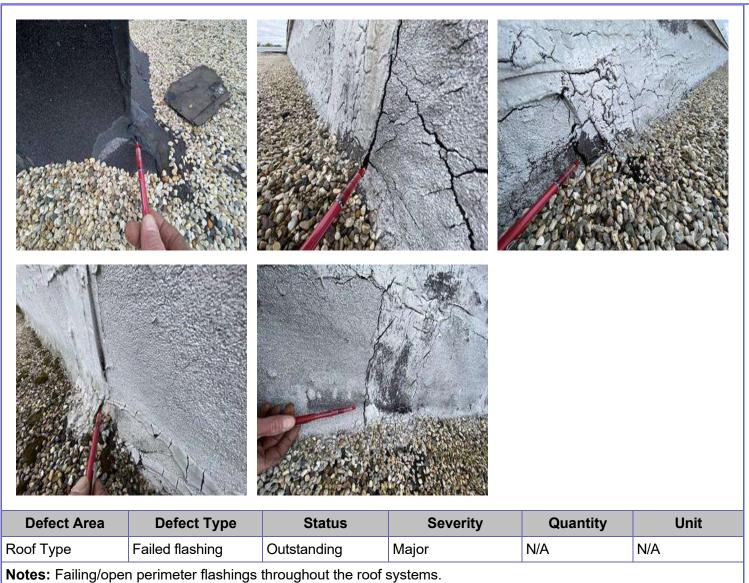
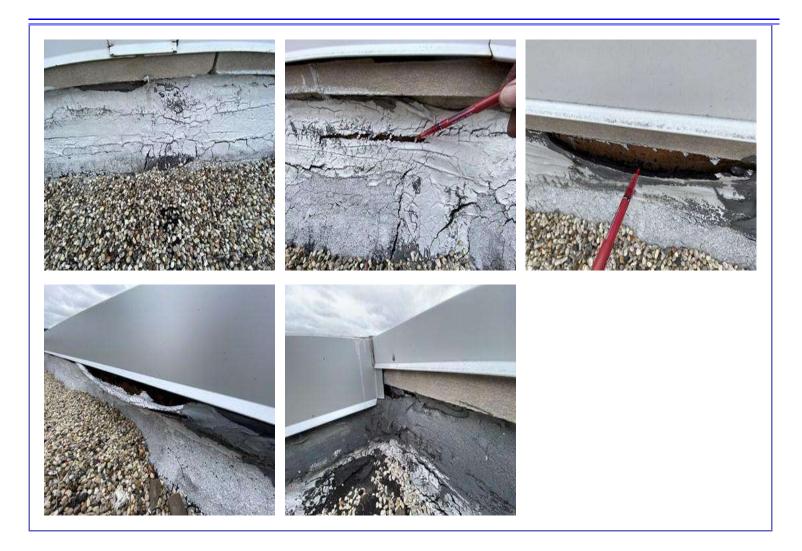
Notes: Split open flashings at curb corners and perimeter flashings throughout the roof system.

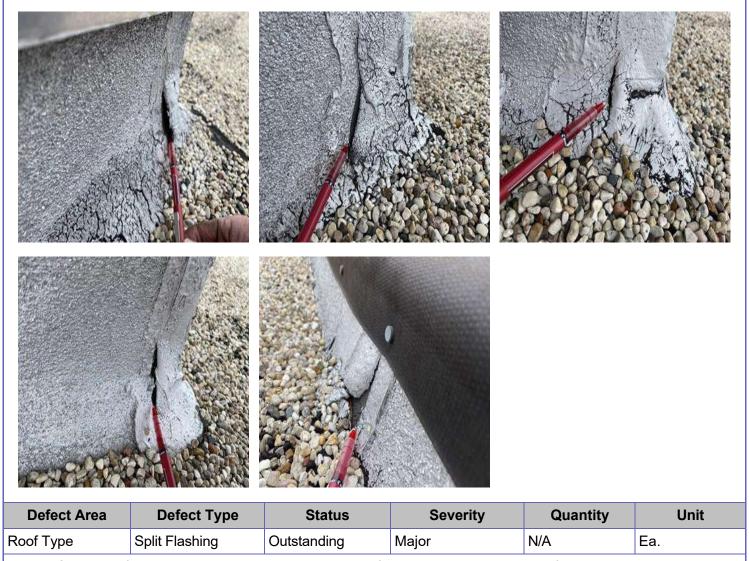
Notes: Open perimeter and curb corner end lap flashings throughout the roof systems.

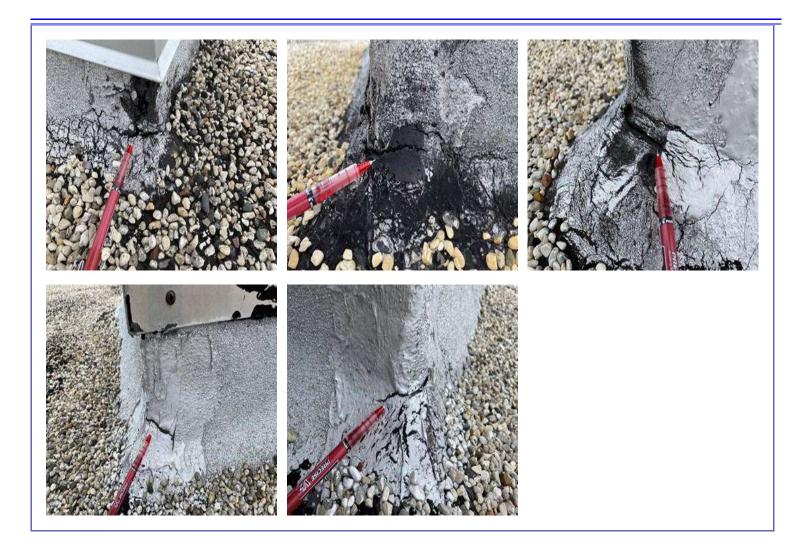
Notes: Split open flashings at curb corners and perimeter flashings throughout the roof system.

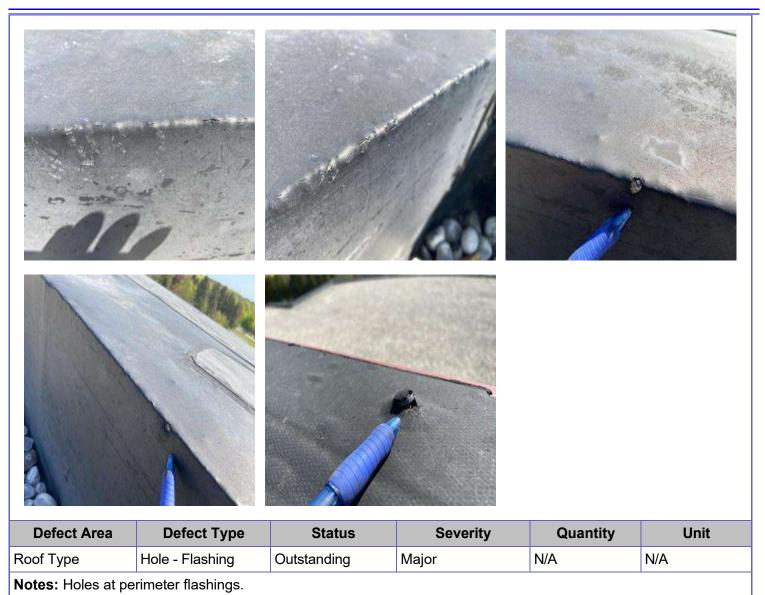
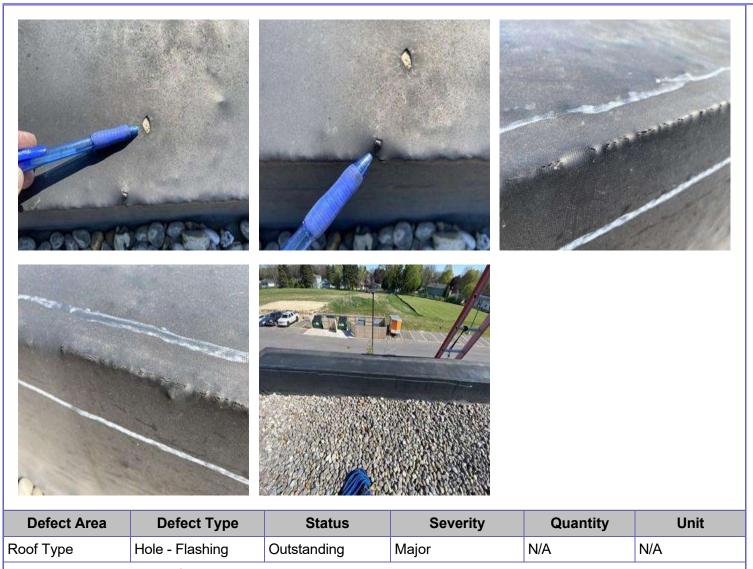
Roof Defects	Section: 28, 29, 30, 31, 32, 33, 34, 35, 37, 38, 39					
Defect Area	Defect Type	Status	Severity	Quantity	Unit	
Roof Type	Hole - Flashing	Outstanding	Major	N/A	N/A	
Notes: Holes at perimeter flashings.

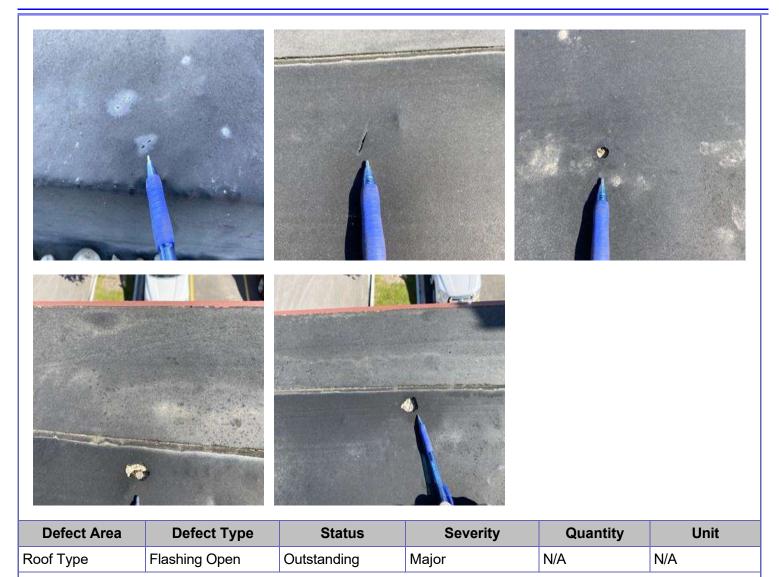
Notes: Holes at perimeter flashings.

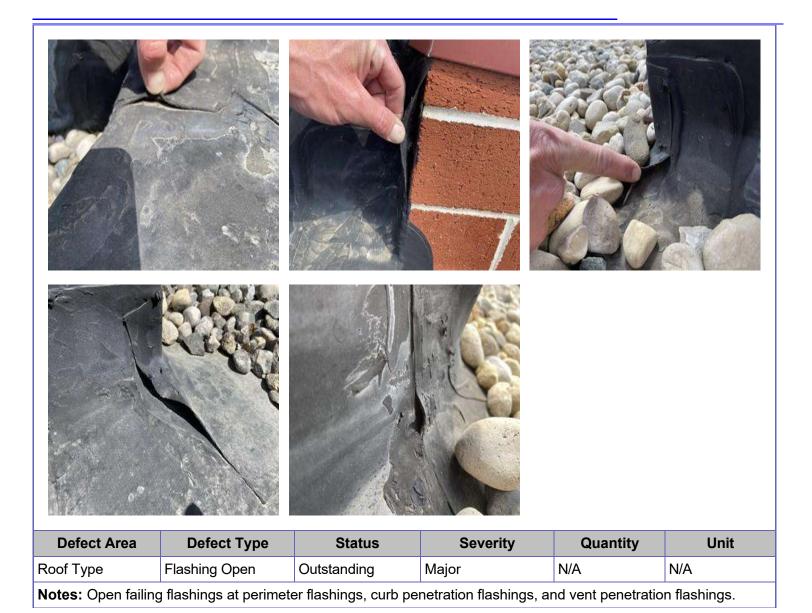
Notes: Open failing flashings at perimeter flashings, curb penetration flashings, and vent penetration flashings.

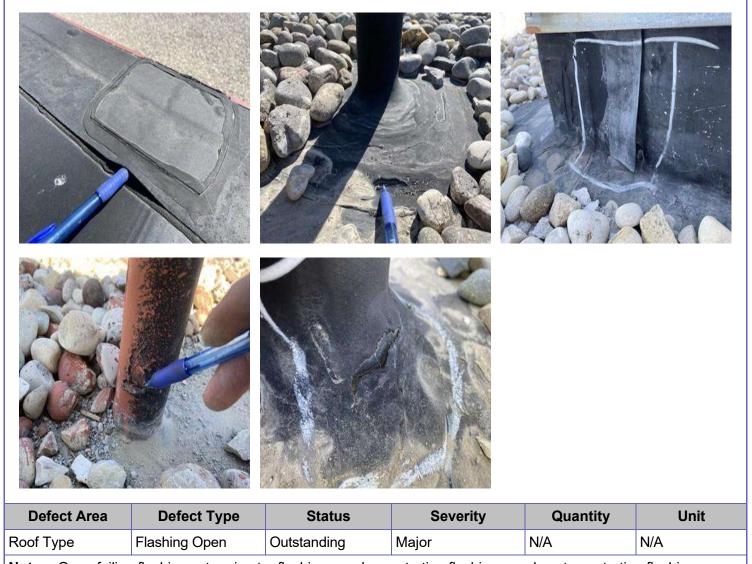
Notes: Open failing flashings at perimeter flashings, curb penetration flashings, and vent penetration flashings.

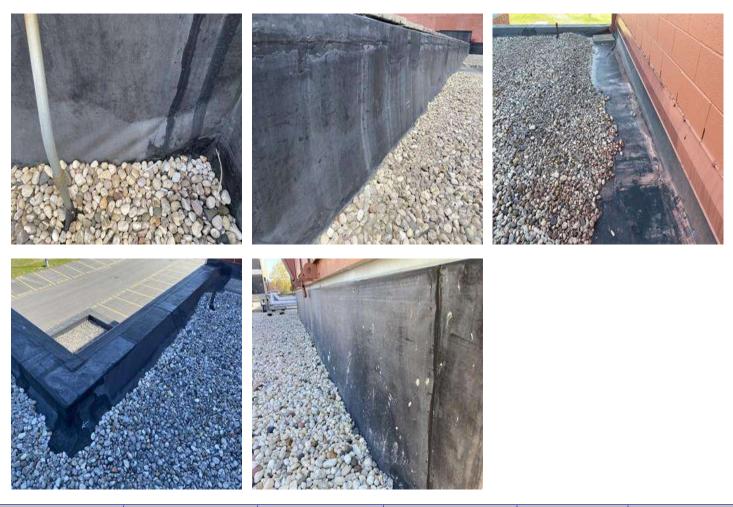
Defect Area	Defect Type	Status	Severity	Quantity	Unit	
Roof Type	Flashing bridging / tenting	Outstanding	Major	N/A	N/A	
Notes: Bridged/tented flashings throughout the roof systems

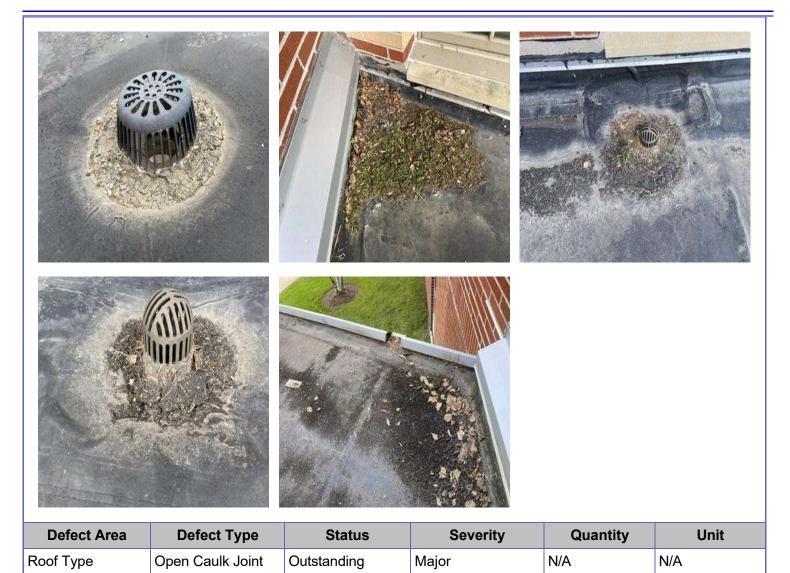
Roof Defects Section : 36, & 50					
Defect Area	Defect Type	Status	Severity	Quantity	Unit
Roof Type	Debris	Outstanding	Major	N/A	N/A
Notes: Plant vegetation debris throughout the roof system, restricting drainage at roof drain basket.

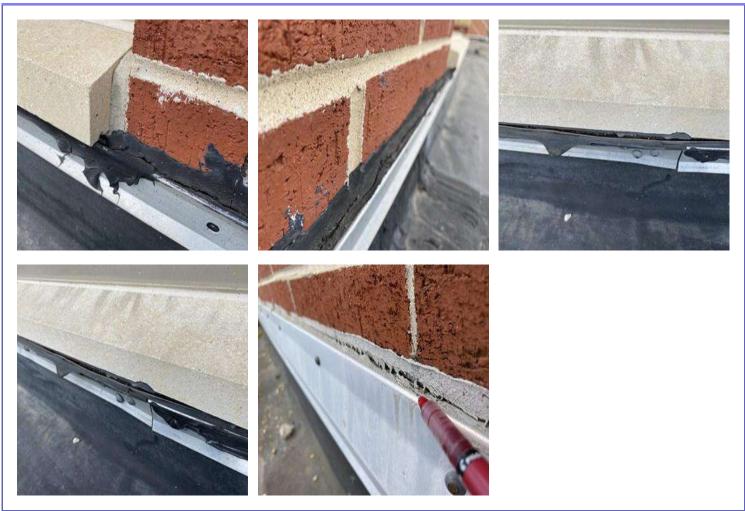
Notes: Open loose termination bar at perimeter flashings. Open caulk seals at metal counterflashings throughout the roof system perimeter flashings.

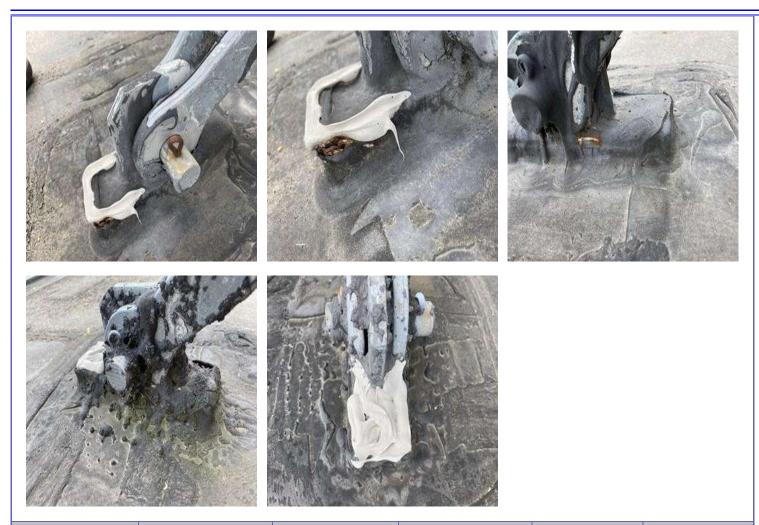
Defect Area	Defect Type	Status	Severity	Quantity	Unit	
Roof Type	Open Pitch Pan	Outstanding	Major	N/A	N/A	
Notes: Open pitch pocket flashings at canopy support rod penetrations, located on roof area 36.

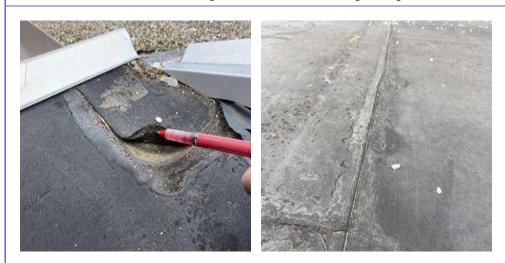
Notes: Field seams and flashing seams observed lifting/failing.

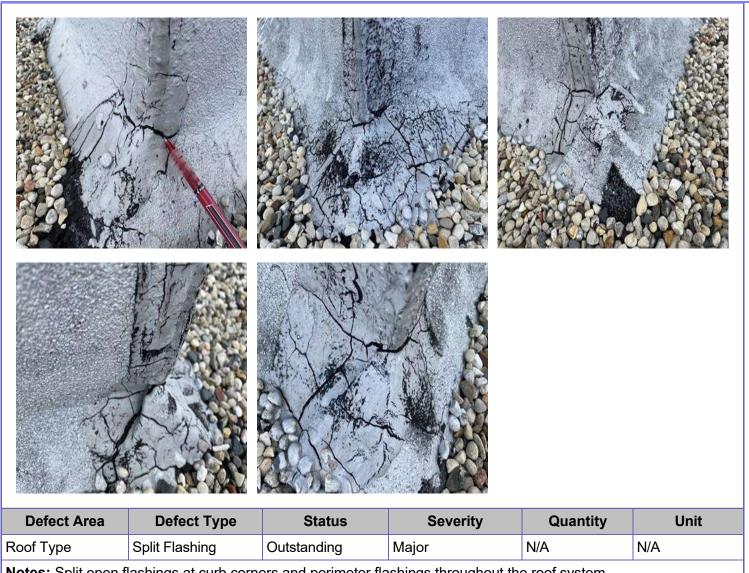
Notes: Split open flashings at curb corners and perimeter flashings throughout the roof system.

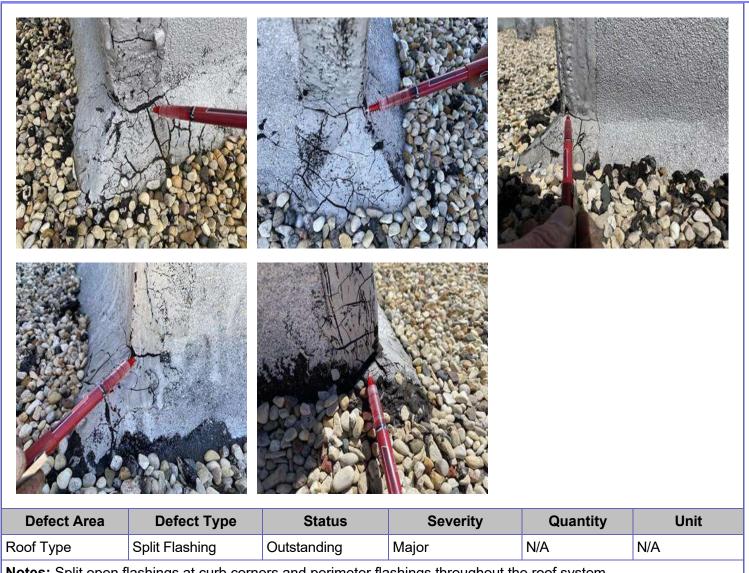
Notes: Split open flashings at curb corners and perimeter flashings throughout the roof system.

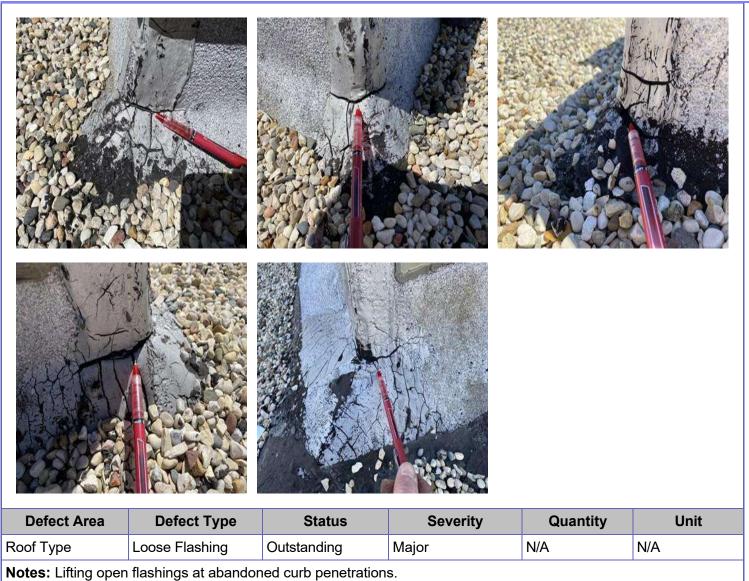
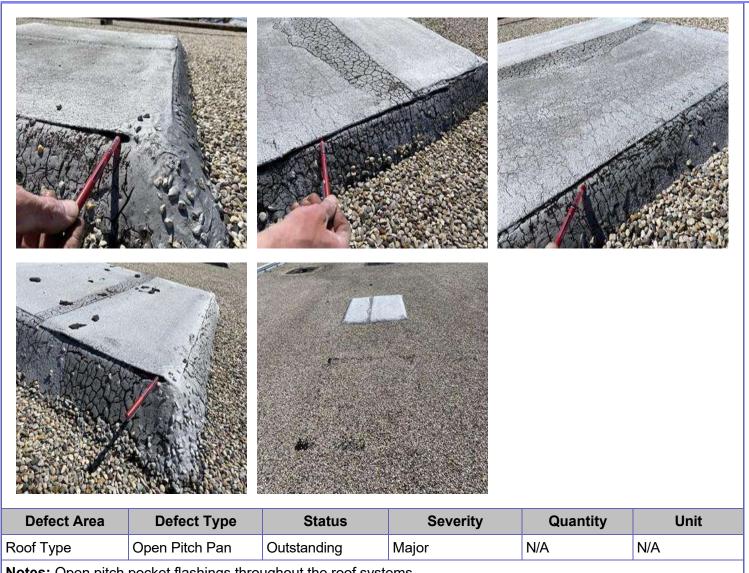
Notes: Split open flashings at curb corners and perimeter flashings throughout the roof system.

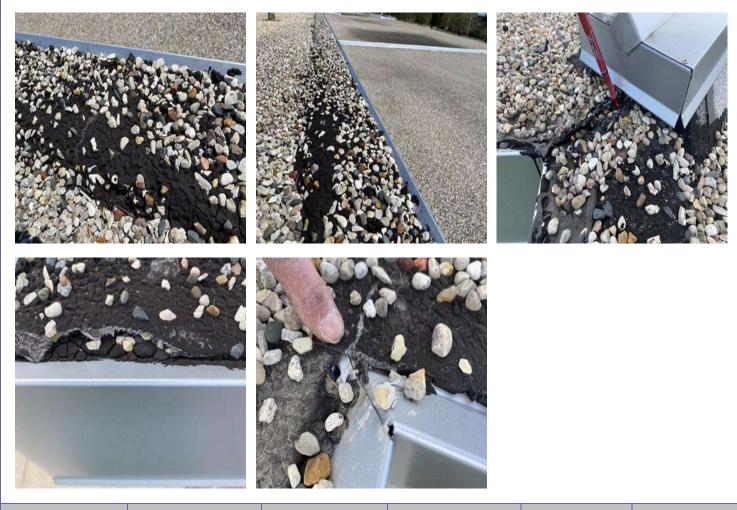
Notes: Failed perimeter flashings throughout the roof systems.

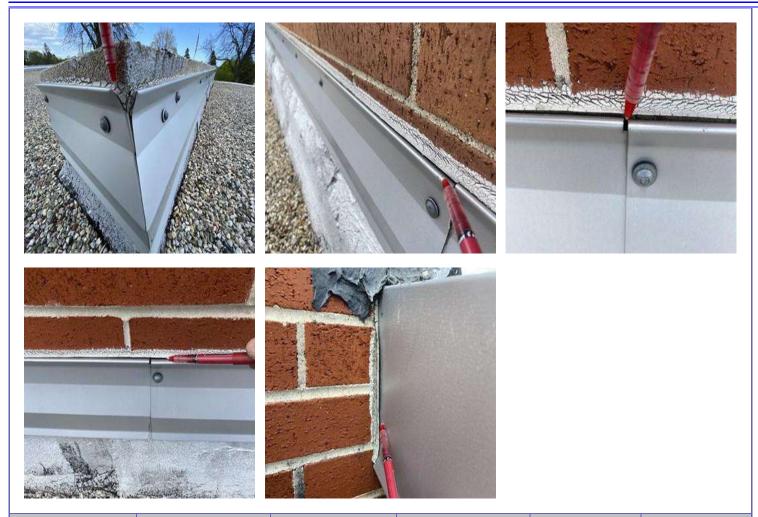
Notes: Open failing caulk seals at perimeter metal counterflashings.

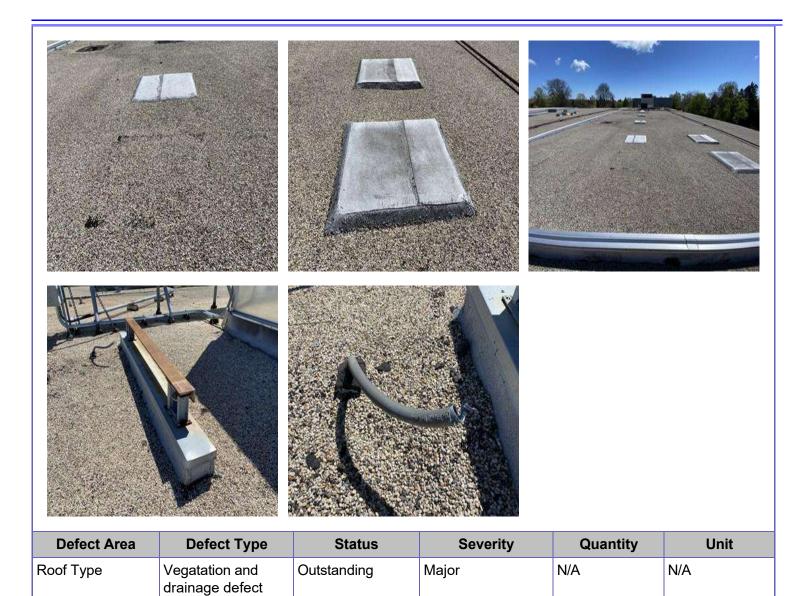
Notes: Abandoned electrical, rail curb penetrations.

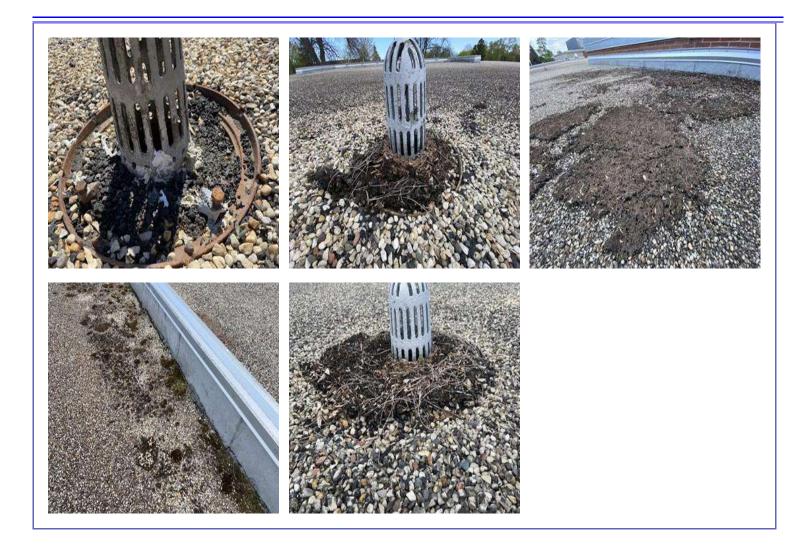
Notes: Plant life vegetation restricting drainage.

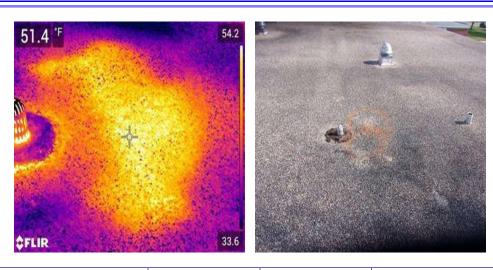
Notes: Anomaly (A#-23) 15 sqft No test cut made on anomaly.

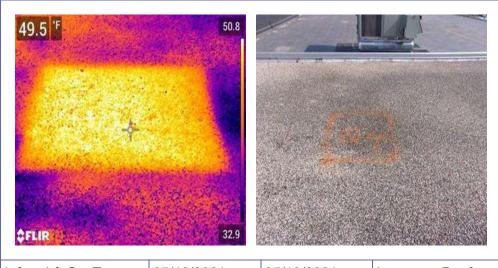
Notes: Anomaly (A#-24) 16 sqft No test cut made on anomaly.

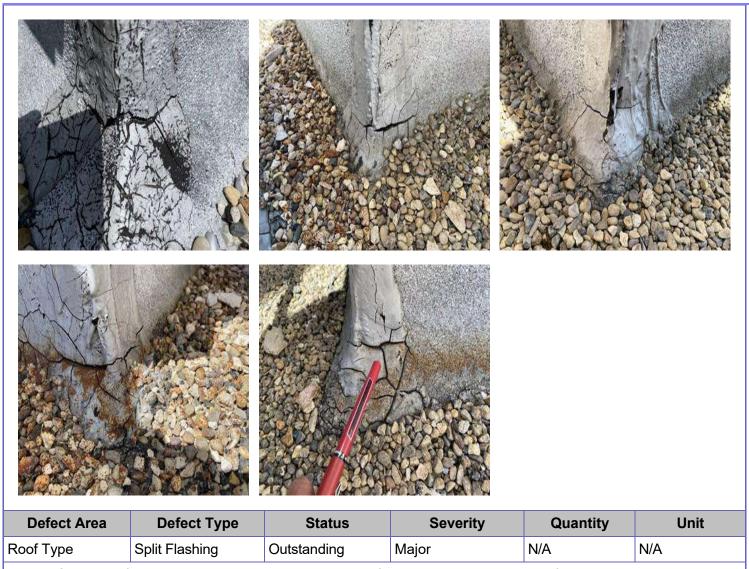
Notes: Split open flashings at curb corners and perimeter flashings throughout the roof system.

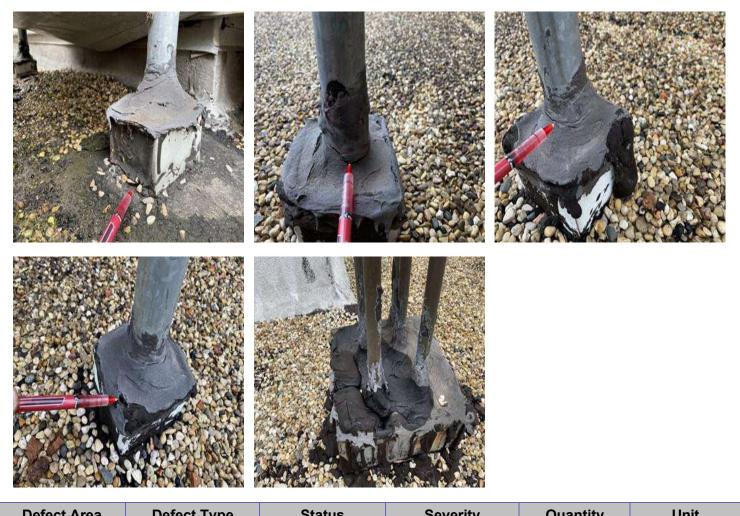
Notes: Open pitch pocket flashings throughout the roof systems.

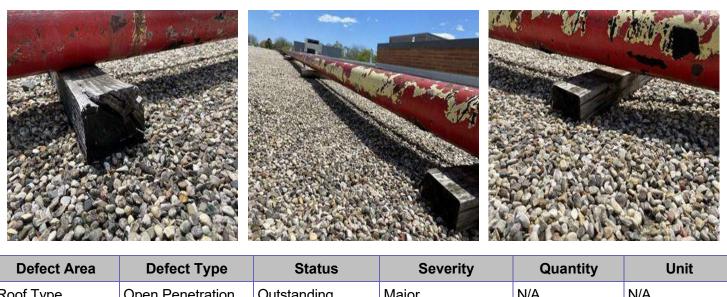
Notes: Failing wood blocking support stand at large gas pipe. Pipe weight/height, causing supports to sink into the roof system.

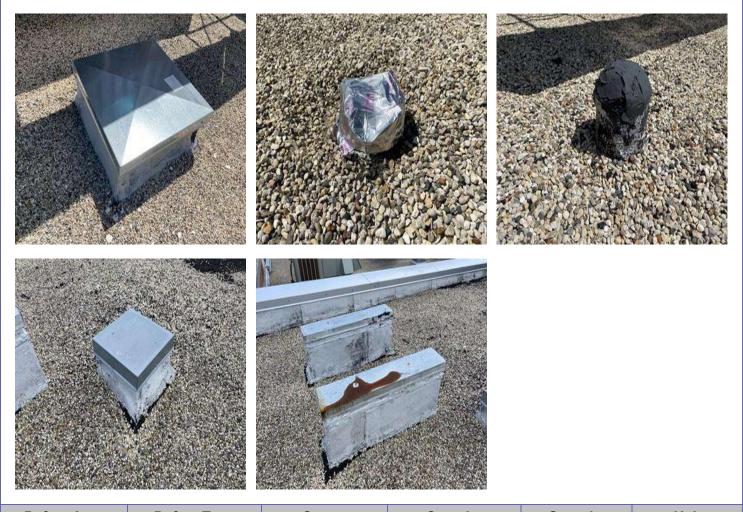
Defect Area	Defect Type	Status	Severity	Quantity	Unit
Roof Type	Abandoned rooftop penetration	Outstanding	Major	5	Ea.
Notes: Abandoned	I rail penetration, and	curb penetrations.

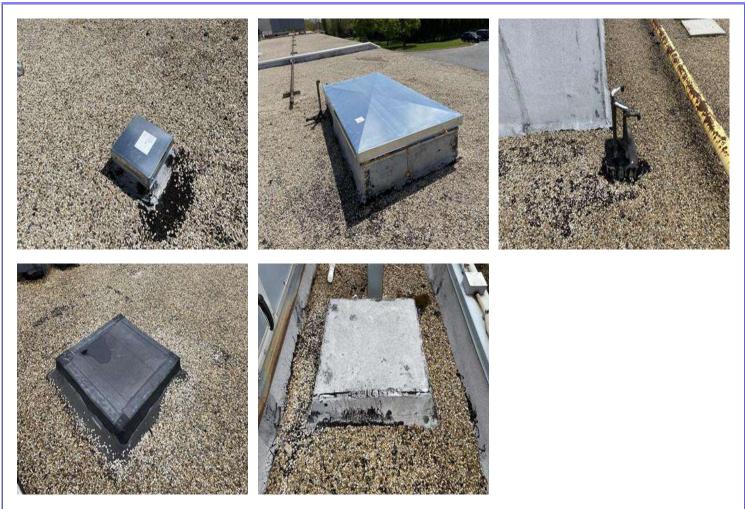
Notes: Abandoned pitch pocket penetration, and curb penetrations.

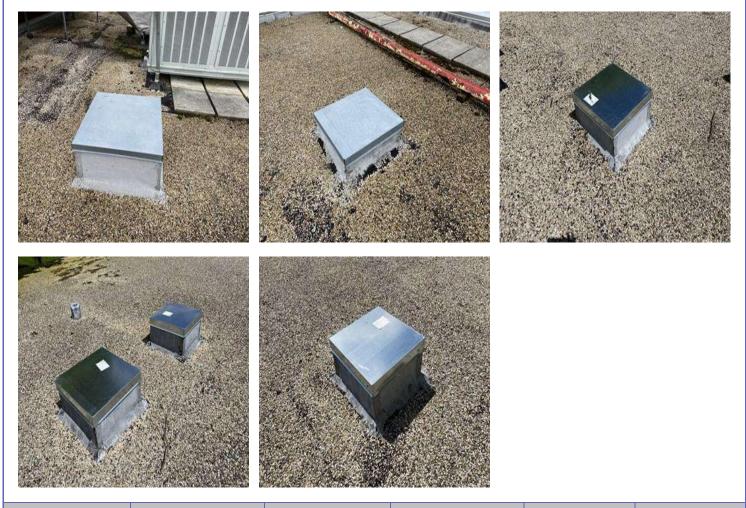
Notes: Abandoned curb penetrations.

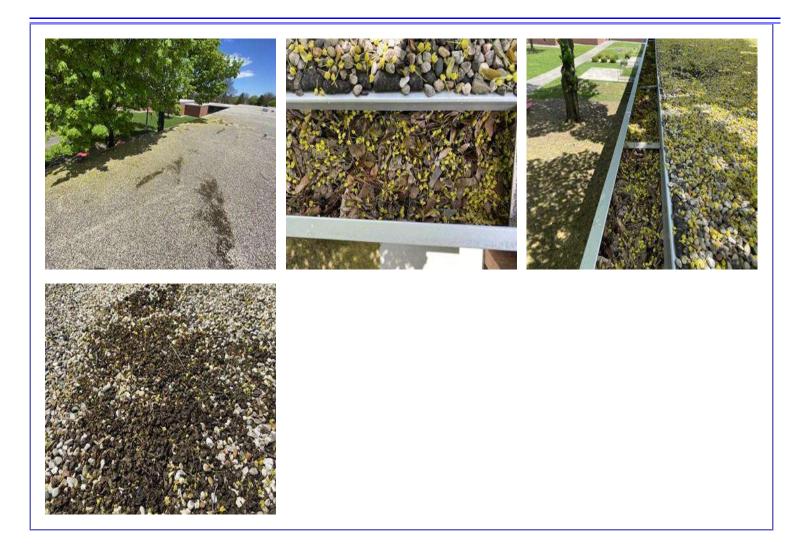
Notes: Plant life vegetation restricting drainage at gutter/downspouts,
