**Extending
Budget
Dollars**

REPAIR VS. REPLACE

**HIGHER EDUCATION
MEQUON, WI**

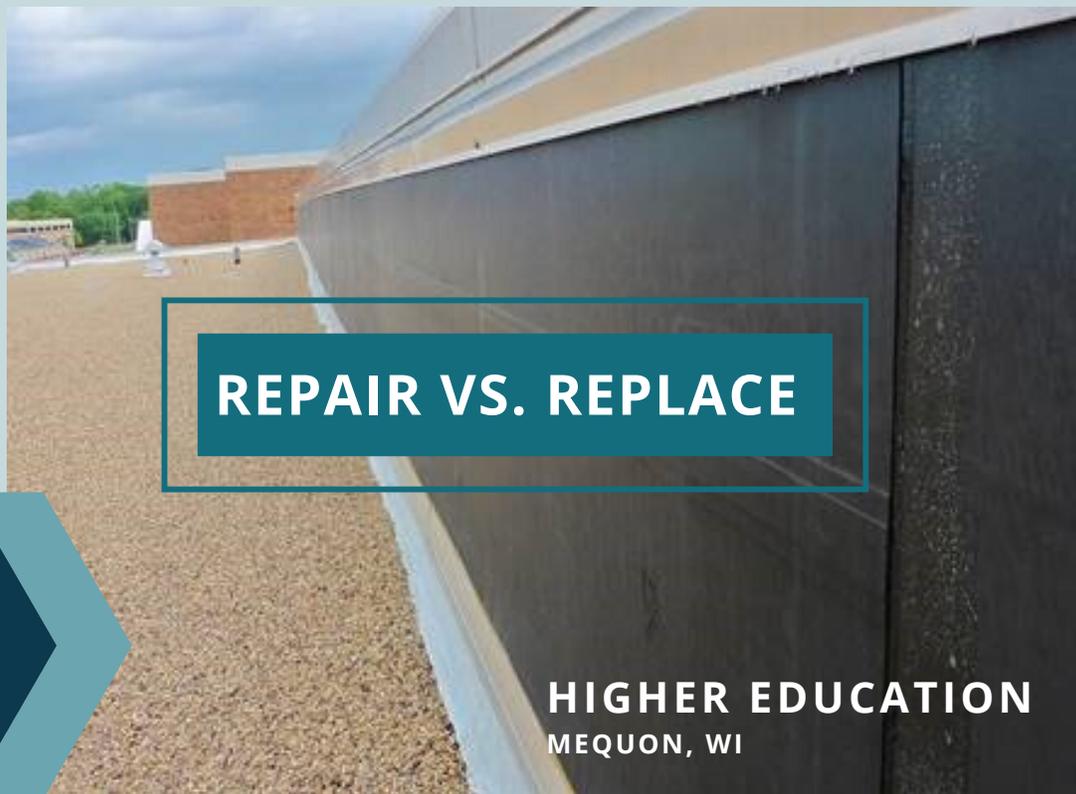
- The roof system at one of the university's buildings had recurring leaks over the years which **involved a difficult parapet wall detail** that relied on a face fastened asbestos wall panel.
- The capital budget required that only half of the roof be replaced. With a limited budget, IRSC needed to **resolve the water leakage issue without exhausting the existing budget** and maintain the aesthetics of the roof system.

- Through systematic water testing, IRSC was able to determine that the roof was not the problem. The **leaking occurred in the asbestos panel**.
- IRSC designed flashing details to allow for encapsulating the asbestos panel, which allowed for only the lower roof of building to be replaced. The roof replacement **stopped the water** entry and resulted in the replacement of upper roof to be postponed for 2 years.

- IRSC was able to design a solution so the lower roof was systematically replaced to **reduce waste, increase cost effectiveness and boost the efficiency** of the roof system.
- The roof to wall flashing and the proper handling of the asbestos panel were **critical to correct** the recurring leak issue. The roofing project had to be designed to allow the roof flashing to be reused on the roof area that was not replaced, in order to not duplicate costs and effort.
