## Facility Condition Report

Sample Deliverable 2

Interstate Roof Systems  
Consultants, Inc.  
16680 W. Cleveland Ave. Ste A,  
New Berlin, Wisconsin, 53151

**Date:** October 11, 2022

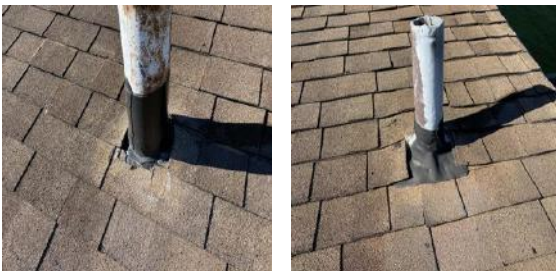
Defect Area	Defect Type	Status	Severity	Quantity	Unit
Roof Type	Flashing	Outstanding	Moderate	2	Ea.

Two soil stacks have incorrect detail flashings.

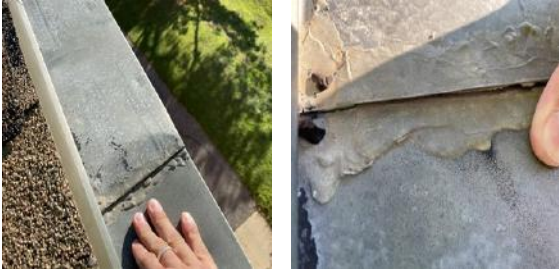
Defect Area	Defect Type	Status	Severity	Quantity	Unit
Roof Type	Joints Open	Outstanding	Moderate	20	Ea.

The solder joints along the roof edge metal are all cracked/open.

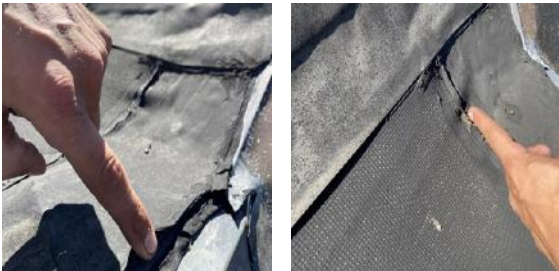
Roof Defects		Section : C10 Earhart Manor - EPDM			
Defect Area	Defect Type	Status	Severity	Quantity	Unit
Roof Type	Open corner flashing	Outstanding	Major	2	Ea.

Open corner flashings were noted in the roof edge and at roof penetrations.

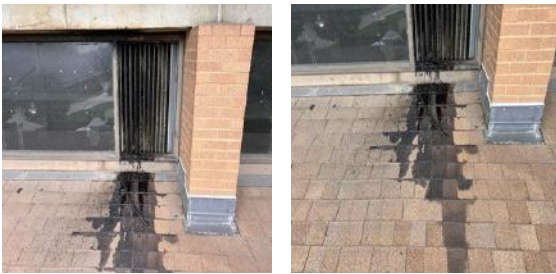
The grease vent is actively leaking onto the shingle roof.

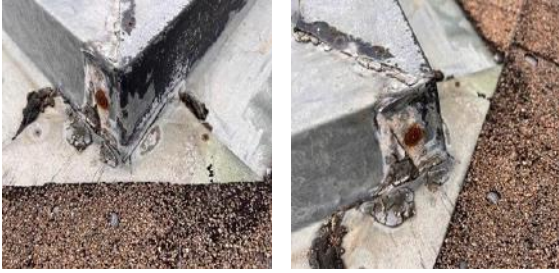
Defect Area	Defect Type	Status	Severity	Quantity	Unit
Roof Type	Deteriorated Caulk Sealants	Outstanding	Major	1	Ea.

Deteriorated caulk at the snow gaurd metal joint.

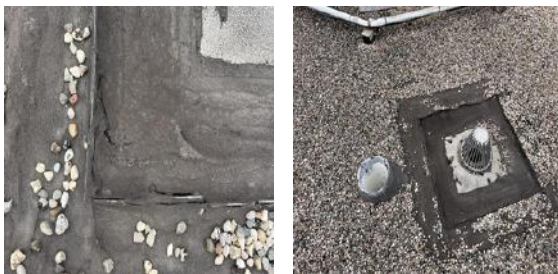
The roof drain has been repaired.

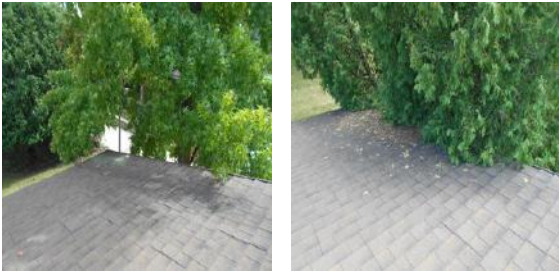
</div>					
Defect Area	Defect Type	Status	Severity	Quantity	Unit
Roof Type	Tree overgrowth	Outstanding	Moderate	2	Ea.
<b>Notes:</b> Tree overgrowth was noted. <div>

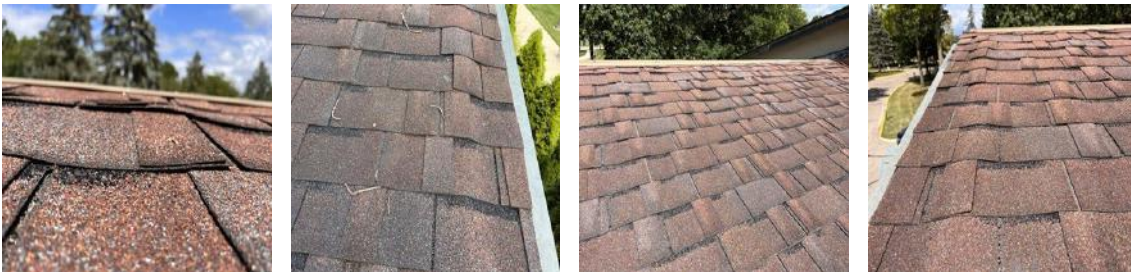
Defect Area	Defect Type	Status	Severity	Quantity	Unit
Roof Type	Buckled Insulation	Outstanding	Moderate	300	sq. ft.

Buckling shingles and insulation was noted on the roof system.

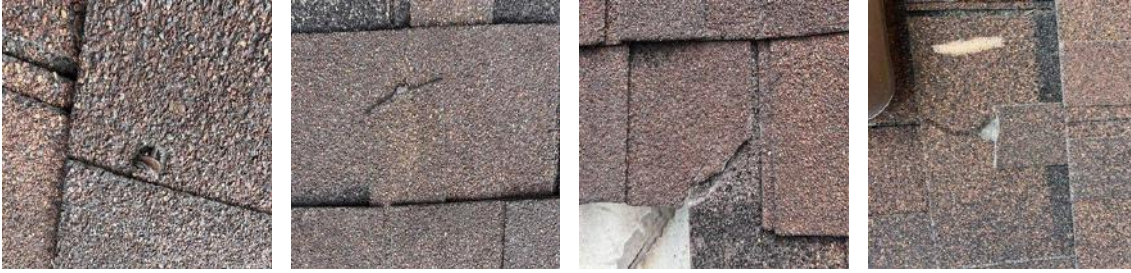
Defect Area	Defect Type	Status	Severity	Quantity	Unit
Roof Type	Shingle Damage	Outstanding	Major	N/A	Various

Shingle damage was noted throughout the roof system.

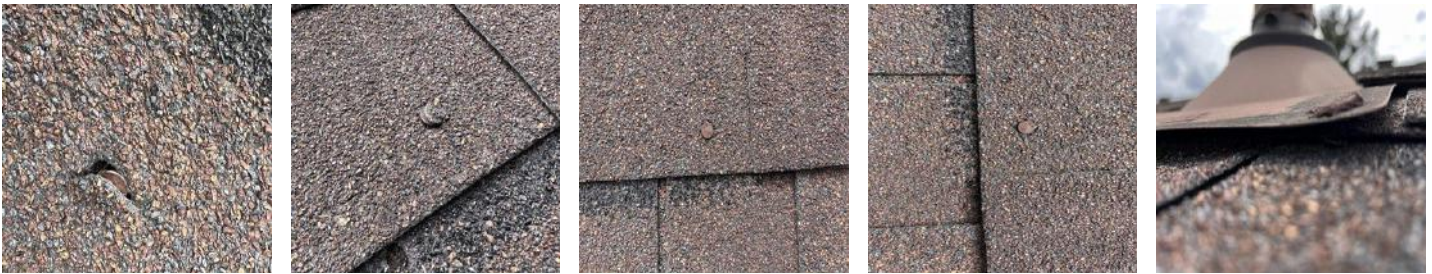
Defect Area	Defect Type	Status	Severity	Quantity	Unit
Roof Type	Exposed Fasteners	Outstanding	Major	N/A	Various

Exposed nails were noted throughout the roof system.

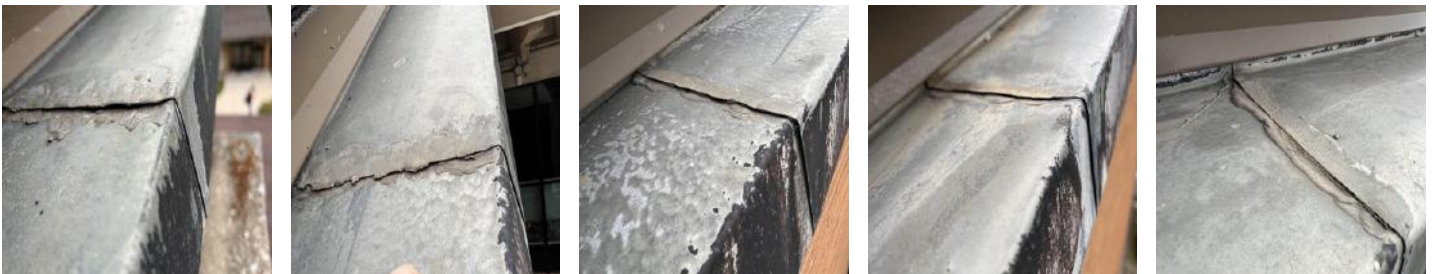
Defect Area	Defect Type	Status	Severity	Quantity	Unit
Roof Type	Open Metal Joints	Outstanding	Moderate	15	Ea.

Open solder joints were noted along all roof edges.

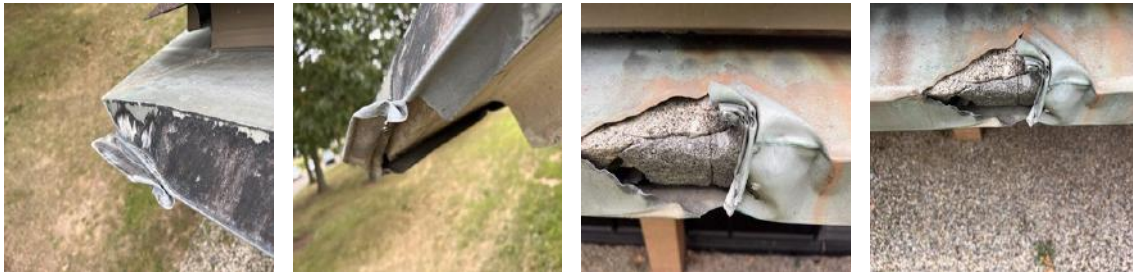
Defect Area	Defect Type	Status	Severity	Quantity	Unit
Roof Type	Damaged	Outstanding	Moderate	2	Ea.

Damaged roof edge metal was noted.

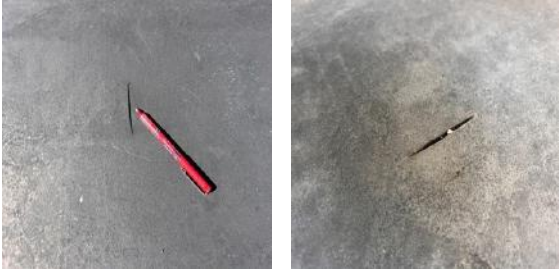
Defect Area	Defect Type	Status	Severity	Quantity	Unit
Roof Type	Mechanical Damage	Outstanding	Major	2	Ea.
<b>Notes:</b> Cuts from mechanical damage were noted on the roof system.

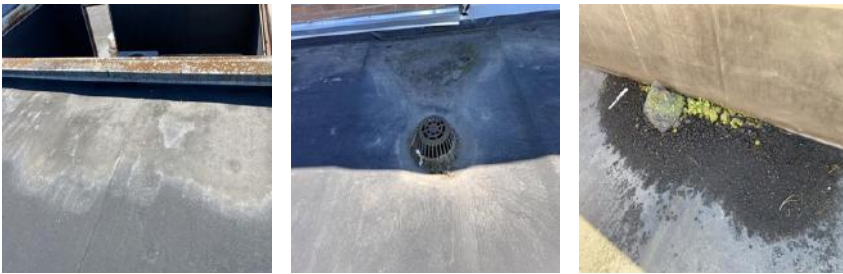
Defect Area	Defect Type	Status	Severity	Quantity	Unit
Roof Type	Ponding	Outstanding	Moderate	25	sq. ft.

Moderate ponding was noted throughout the roof system.

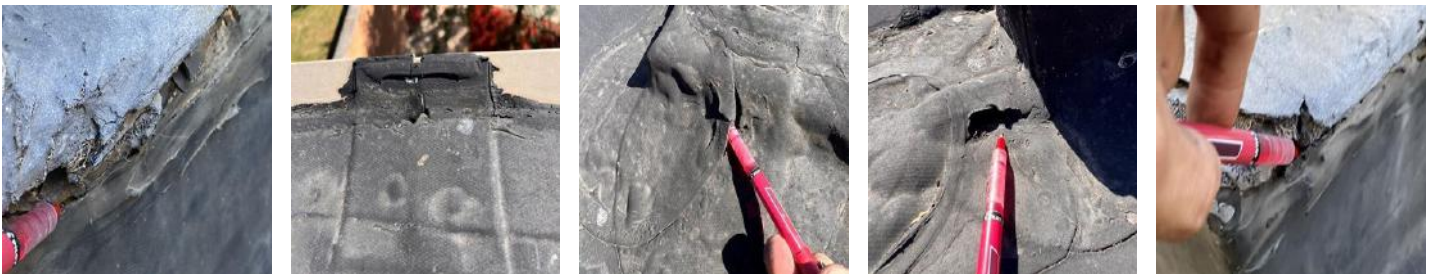
Defect Area	Defect Type	Status	Severity	Quantity	Unit
Roof Type	Open Flashing	Outstanding	Major	30	Ea.

Flashings throughout the roof system were noted to be open.

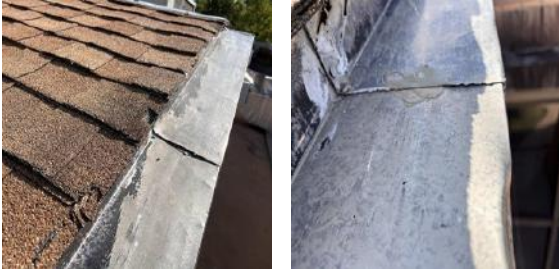
Defect Area	Defect Type	Status	Severity	Quantity	Unit
Roof Type	Open Metal Joints	Outstanding	Moderate	N/A	Various
<b>Notes:</b> The solder joints are noted to be open along all roof edges.

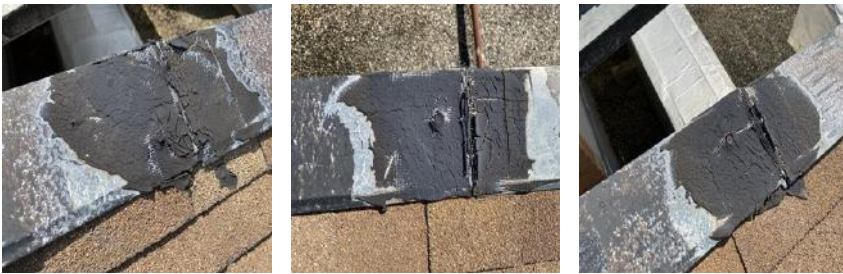
Defect Area	Defect Type	Status	Severity	Quantity	Unit
Roof Type	Open Metal Joints	Outstanding	Major	N/A	Various

Metal joints were noted to be open along the roof ridges.

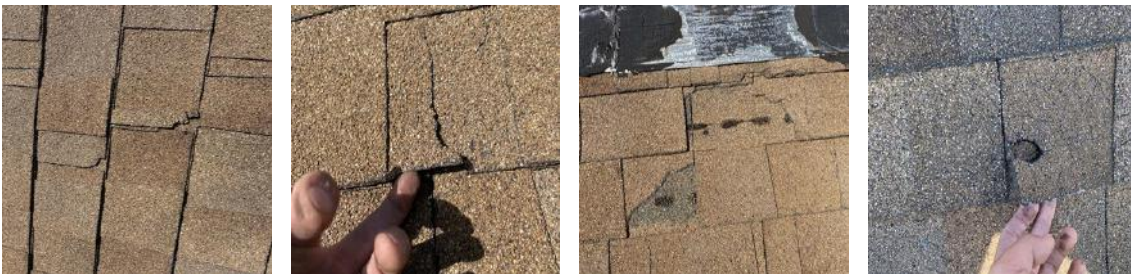
Defect Area	Defect Type	Status	Severity	Quantity	Unit
Roof Type	Shingle Damage	Outstanding	Major	N/A	Various

Shingle damage was noted through out all roof systems.

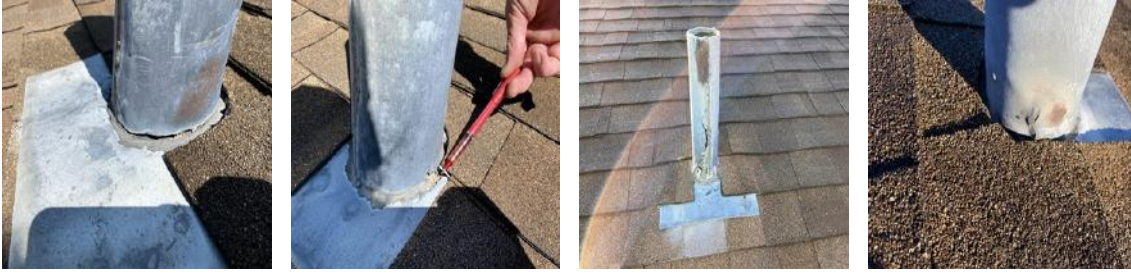
Defect Area	Defect Type	Status	Severity	Quantity	Unit
Roof Type	Deteriorated Flashing	Outstanding	Major	20	Ea.

Lead soil stack flashings are noted to be deteriorated.

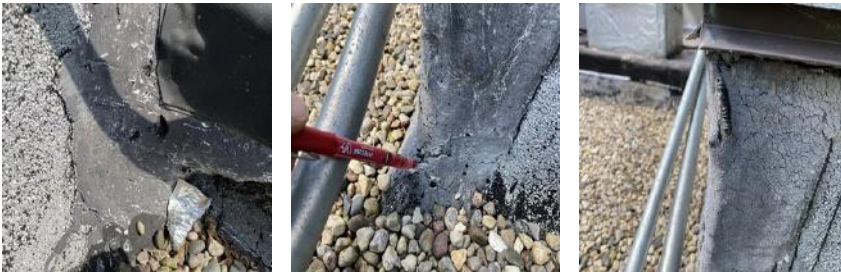
Defect Area	Defect Type	Status	Severity	Quantity	Unit
Roof Type	Open corner flashing	Outstanding	Major	N/A	Various

Open corner flashings were noted on several of the built-up roof systems.

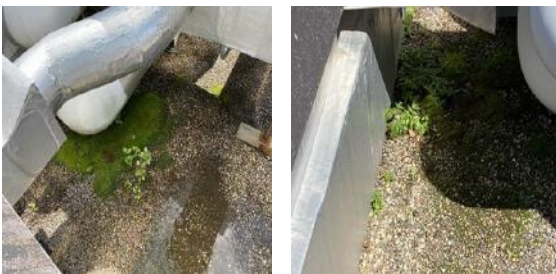
Defect Area	Defect Type	Status	Severity	Quantity	Unit
Roof Type	Vegetation/moss/growth	Outstanding	Moderate	25	sq. ft.

Vegetation growth was noted on multiple roof systems.

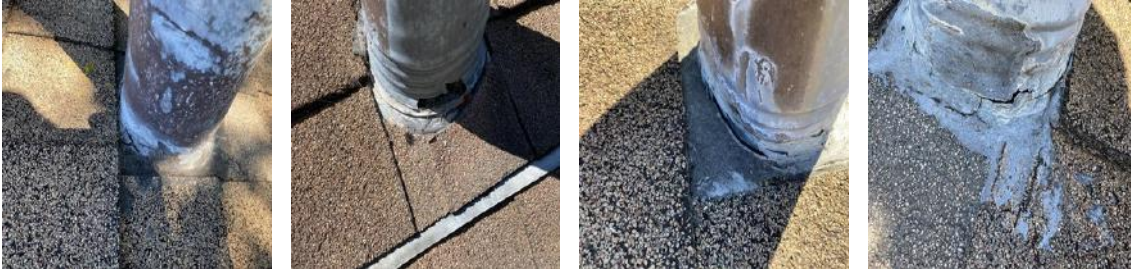
Defect Area	Defect Type	Status	Severity	Quantity	Unit
Roof Type	Flashing Deteriorated	Outstanding	Major	N/A	Various
<b>Notes:</b> Multiple lead soil stack flashings wer observed to be deteriorated.

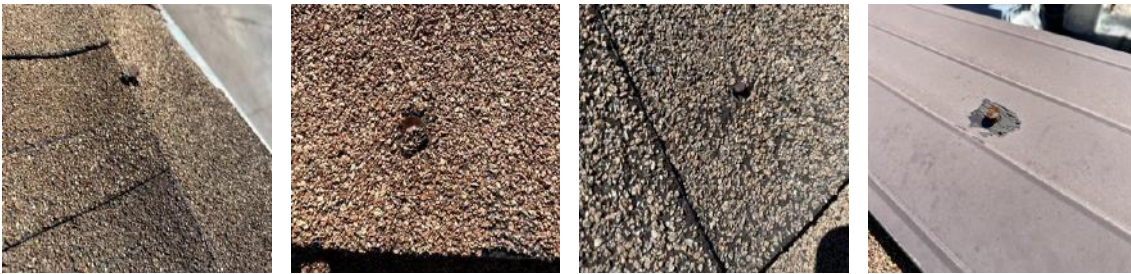
Defect Area	Defect Type	Status	Severity	Quantity	Unit
Roof Type	Exposed Fasteners	Outstanding	Major	N/A	Various

Exposed nails are noted on all roof systems.

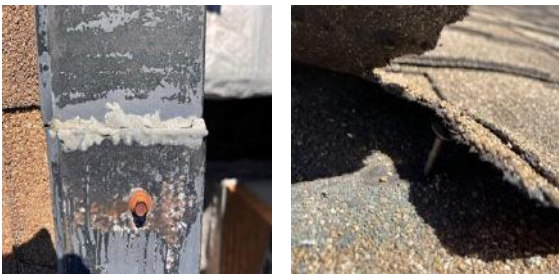
Defect Area	Defect Type	Status	Severity	Quantity	Unit
Roof Type	Backout Fasteners	Outstanding	Major	N/A	Various

Multiple fasteners are backing out on all roof systems.

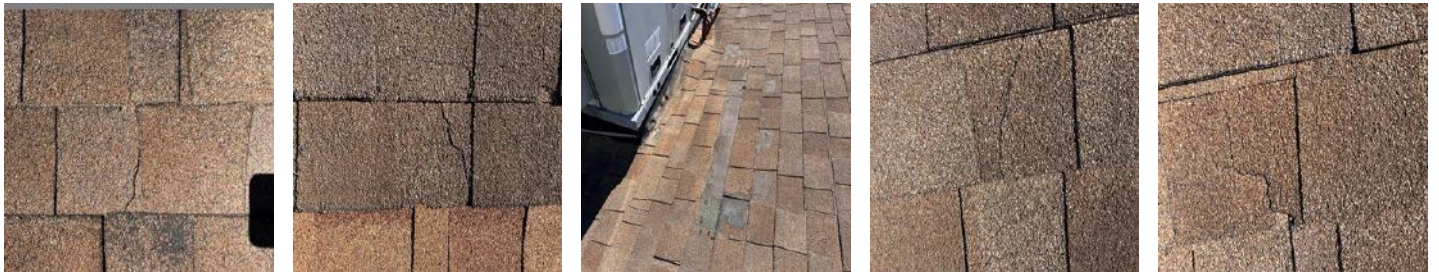
Defect Area	Defect Type	Status	Severity	Quantity	Unit
Roof Type	Shingle Damage	Outstanding	Major	N/A	Various
<b>Notes:</b> Shingle damage was noted throughout the roof systems.

Perform annual preventative maintenance on roof section R14,15,20 consisting of:  
1. Caulking of exposed fasteners, damaged shingles, and open flashings.

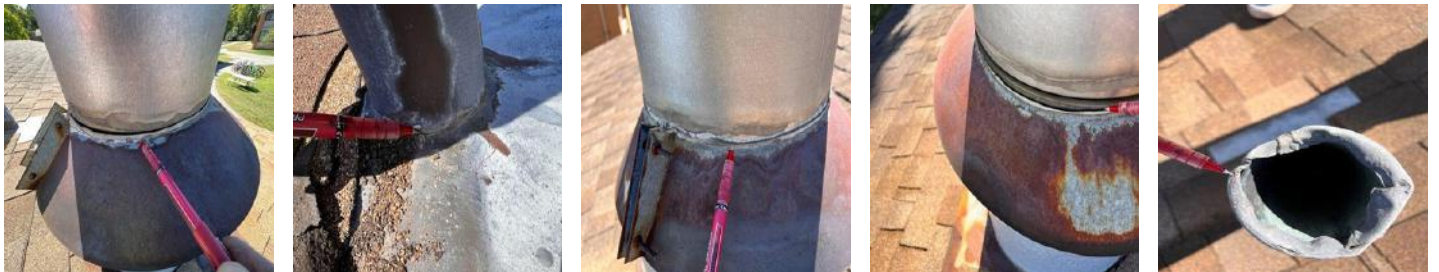
Defect Area	Defect Type	Status	Severity	Quantity	Unit
Roof Type	Flashing Deteriorated	Outstanding	Major	N/A	Various

Multiple soil stack and flue stack metal flashings were deteriorated and open.

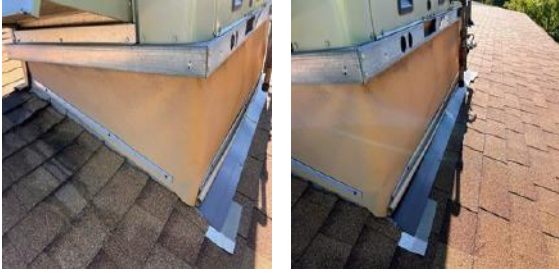
Defect Area	Defect Type	Status	Severity	Quantity	Unit
Roof Type	Improper - Flashing	Outstanding	Moderate	1	Ea.

Chimney flashing was noted to be improperly flashed.

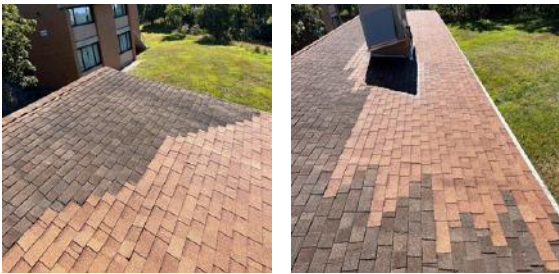
Defect Area	Defect Type	Status	Severity	Quantity	Unit
Roof Type	Repairs Overview	Outstanding	Minor	250	sq. ft.

Repairs have previously been made on one of the roof systems.

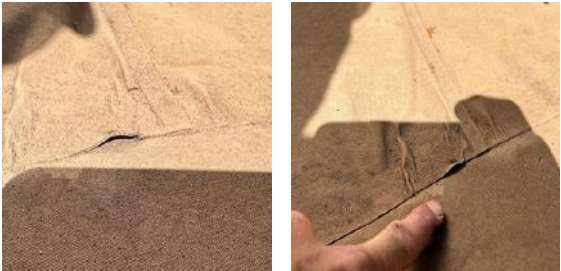
Roof Defects		Section : R2,3 Residential Halls - Duro-Last			
Defect Area	Defect Type	Status	Severity	Quantity	Unit
Roof Type	Open Lap	Outstanding	Major	2	Ea.
<b>Notes:</b> Open laps were noted in the roof membrane.

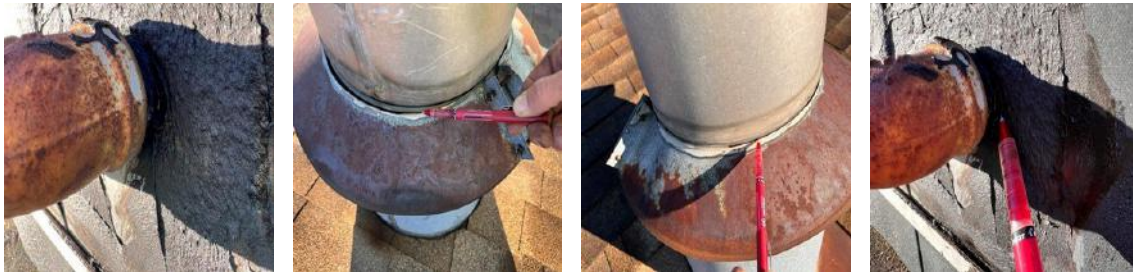
Defect Area	Defect Type	Status	Severity	Quantity	Unit
Roof Type	Deteriorated Flashing	Outstanding	Major	2	Ea.

It was observed that the soil stack and flue stack flashings are deteriorated and open.

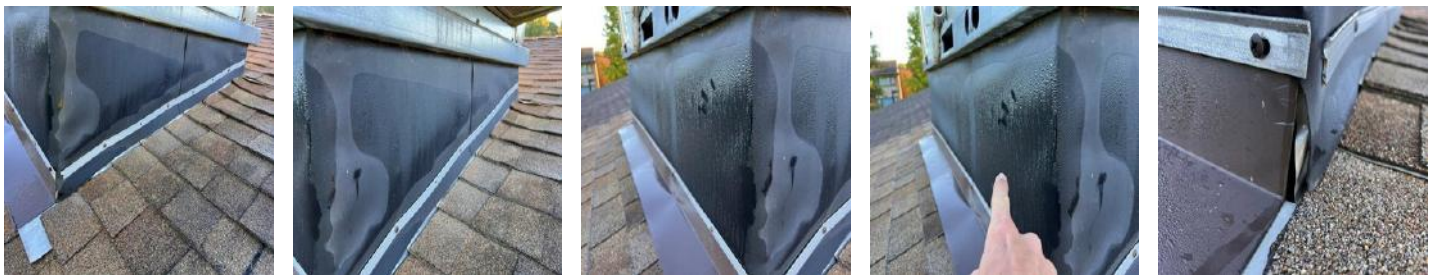
Defect Area	Defect Type	Status	Severity	Quantity	Unit
Roof Type	Flashing	Outstanding	Major	3	Ea.

Holes were observed in the curb flashing for the RTU.

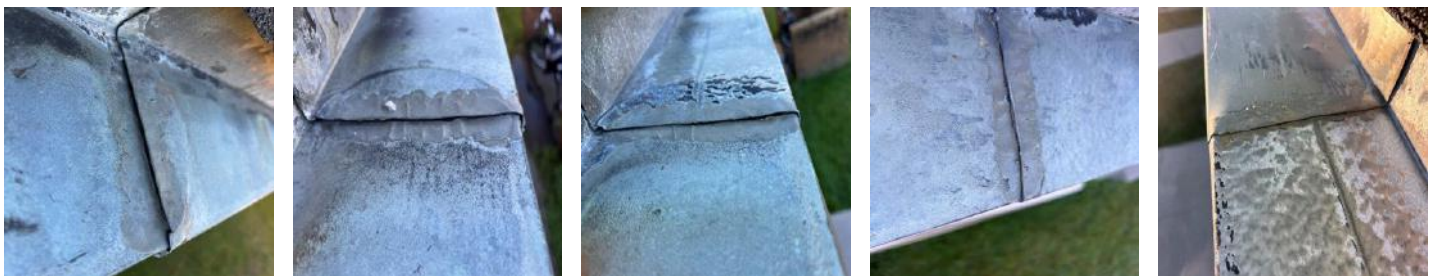
Defect Area	Defect Type	Status	Severity	Quantity	Unit
Roof Type	Open Metal Joints	Outstanding	Moderate	N/A	Various

Solder joints along the roof edges are open.
