The Challenge

Diagnosis and Solution

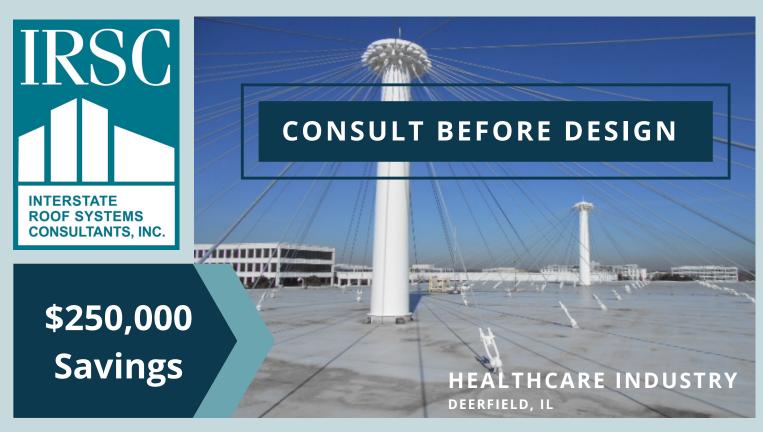
- The 40,000 square foot building has a **unique cable supported roof structure**. Two concrete-filled steel tube columns with 98 structural cables and turnbuckle connections provide support of the 6" thick, long-span metal roof deck.
- The roof evaluation **provided the owner with several design solutions** to consider. Once the desired design solution was selected, IRSC designed a new 20-year thermoplastic roof system with a pre-engineered metal roof edge system. Custom detailing was also required at all of the turn-buckle support locations.

- By providing a roof evaluation prior to design, the owner was able to consider a roof recovery design solution. This also provided a long-term design solution with approximately a 35% cost savings over a complete removal and replacement option.
- This option had a construction cost of approximately \$450,000 compared to the estimated cost of \$700,000 for a complete replacement. **This represented a cost savings of approximately \$250,000 to the owner.**
