The Challenge

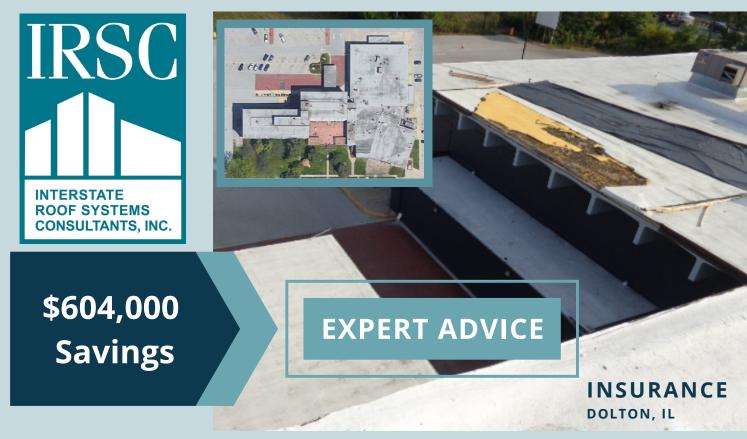
- Due to a "Derecho" storm event, high winds in the area caused a partial blow-off on a section of a roof that had been recently recoated with a silicone roof coating, a majority of the sheet metal flashing was also damaged.
- IRSC was hired to provide a second opinion after initial claims service reviewed and rendered findings. The building owner rejected the initial findings and funds for the roof, claiming the entire roof required replacement due to the coating materials.

- The insurance provider requested a peer review of IRSC's assessment and repair strategy. The peer review of the roof damage and repair strategies were in support of IRSC's findings. This equated into a cost-effective repair solution and recommendations limiting the request of a complete roof replacement on the entire building.
- Prior to IRSC providing their repair recommendations, they conducted mock-up test to confirm the repair strategy and performance.

- Our expert advice resulted in the Insurance Company paying a claim of only \$141,000 vs. the original estimated \$700,000 to \$745,000 for a full roof replacement.
- IRSC was able to developed a unique repair option that followed industry standard practices for a challenging coating material that was recently applied, resulting in a significant cost savings.
